Access Compliance Report

Public Rights-of-Way

(Curb Ramps)

Intersection ID: N/A	Main Street: CAMERON_VALLEY_PY	Cross Street: PHILLIPS_PLACE_CT	Location: SW
ADA ID: 0E23184A49EC	Ramp Type: Perp	Initial Pass/Fail: Fail	Overall Compliance: No
		Severity Score: 1.25

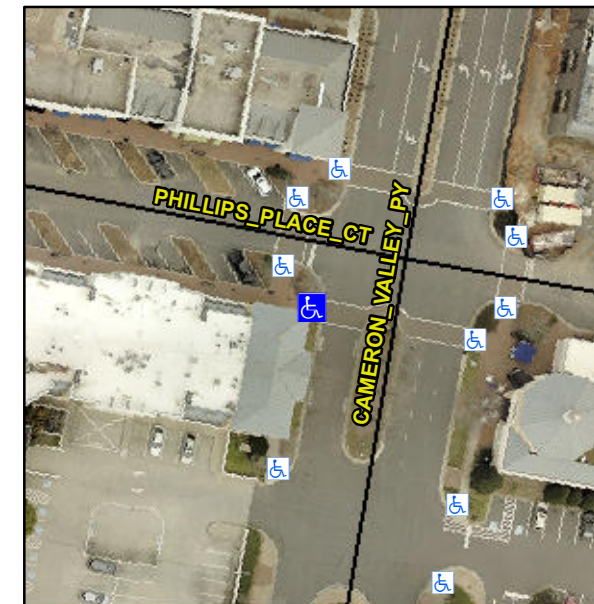
Not Found, R304.5.3

Compliance	Description	Data	Compliance	Description	Data
N/A	Ramp Length (in)	70.0	Yes	Ramp Slope (%)	6.5
Yes	Ramp Width (in)	131.0	No	Ramp XSlope (%)	3.0
N/A	Flare Type LT	N/A	N/A	Flare Type RT	N/A
N/A	Flare Slope LT (%)	N/A	N/A	Flare Slope RT (%)	N/A
N/A	Flare Traversable LT?	N/A	N/A	Flare Traversable RT?	N/A
N/A	Landing Length (in)	N/A	N/A	DWS Provided?	N/A
N/A	Landing Width (in)	N/A	N/A	DWS Contrast?	N/A
N/A	Landing Slope (%)	N/A	N/A	DWS Length (in)	N/A
N/A	Landing X Slope (%)	N/A	N/A	DWS Full Width?	N/A
N/A	Landing Curb? (Y/N)	N/A	N/A	DWS Offset (in)	N/A
N/A	Shared Landing?	N/A			
N/A	Gutter Ponding?	N/A	N/A	Gutter Slope (%)	N/A
N/A	Gutter Lip Ht (in)	N/A	N/A	Gutter X Slope (%)	N/A
N/A	Painted X Walk1?	Yes	N/A	Painted X Walk2?	N/A
	X Walk 1 Direction	To SE		X Walk 2 Direction	N/A
N/A	X Walk 1 Width (in)	131.0	N/A	X Walk 2 Width (in)	N/A
	X Walk 1 Slope (%)	1.9		X Walk 2 Slope (%)	N/A
	X Walk 1 X Slope (%)	0.4		X Walk 2 X Slope (%)	N/A

Remove & Replace Entire Ramp.
