# Access Compliance Report

## Public Rights-of-Way

### (Curb Ramps)

| Intersection ID: 19325 | Main Street: KREFELD_DR | Cross Street: MARGARET_WALLACE_RD | Location: W |

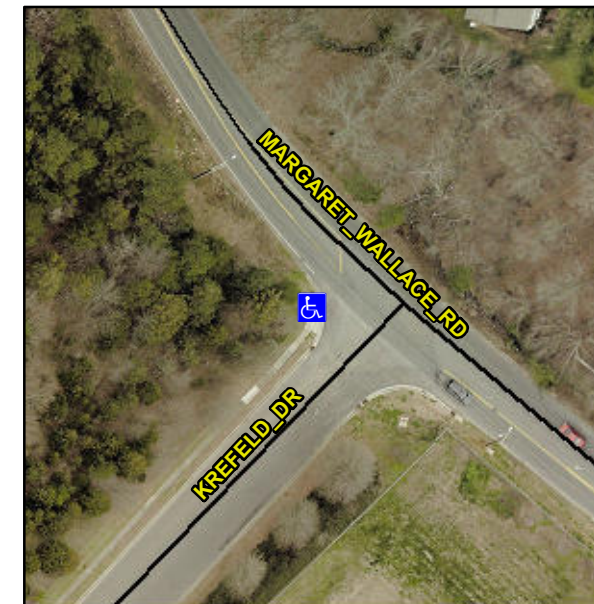
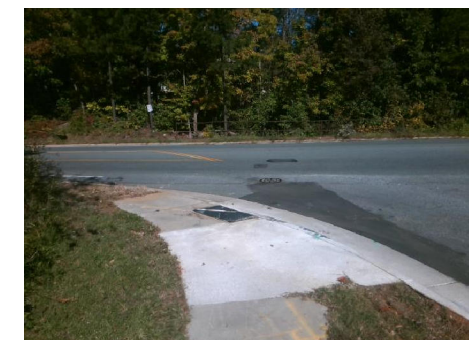
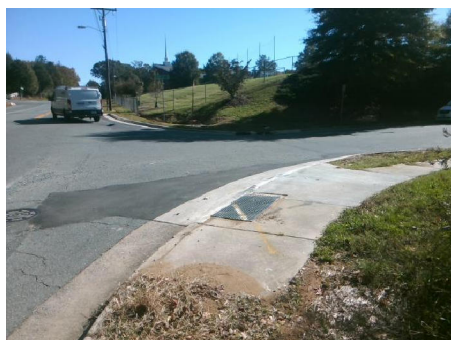
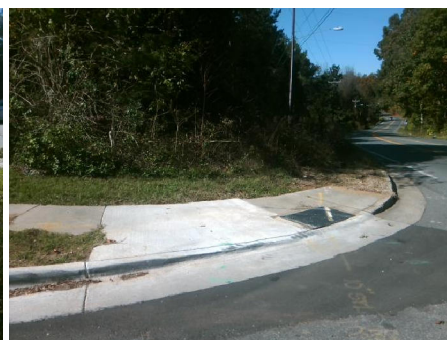
**RT RP < 5%**

**R304.5.3, R304.2.2-Perp, R304.3.2-Para**

| Compliance | Description | Data | Compliance | Description | Data |
|---|---|---|---|---|---|
| No | Ramp XSlope LT (%) | 4.6 | Yes | Ramp XSlope RT (%) | 0.2 |
| No | Landing Slope (%) | 3.4 | Yes | DWS Length (in) | 25.5 |
| No | Landing X Slope (%) | 6.7 | Yes | DWS Full Width? | Yes |
| Yes | Gutter Lip Ht (in) | 0.0 | No | Gutter X Slope (%) | 5.6 |

**Remove & Replace Curb Ramp With Two New Directional Ramps or Equivalent. Remove & Replace Gutter.**
