# Access Compliance Report

## Public Rights-of-Way

### (Curb Ramps)

| Intersection ID: 10035268 | Main Street: QUEENS_RD | Cross Street: N/A | Location: N |

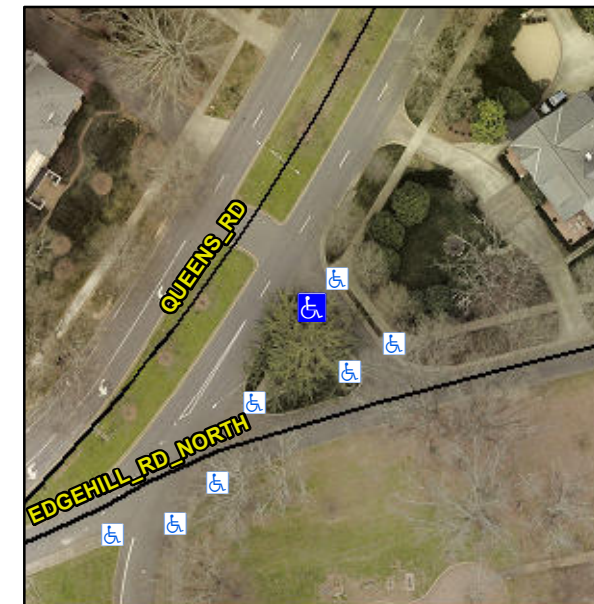
| ADA ID: 0E31628C3FCF | Ramp Type: BlendTrans1 | Initial Pass/Fail: Fail | Overall Compliance: No |
| Severity Score: 1.25 | | | |

**R304.5.3**

| Compliance | Description | Data | Compliance | Description | Data |
|---|---|---|---|---|---|
| Yes | Ramp Width (in) | 48.0 | No | BlendTrans XSlope (%) | 2.8 |

**Remove & Replace Curb Ramp With Two New Directional Ramps or Equivalent.**

Total Cost: \$ 3200.00

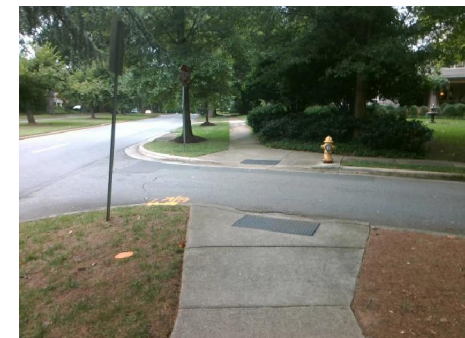
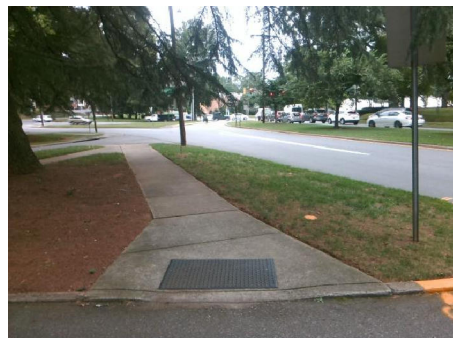
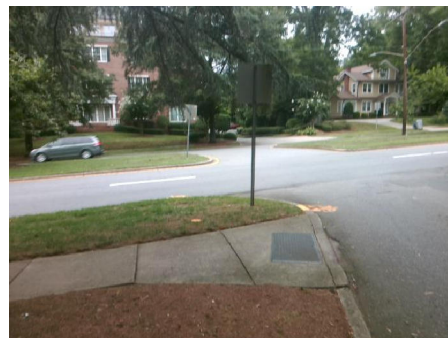
| Compliance | Description | Data | Compliance | Description | Data |
|---|---|---|---|---|---|
| | | | Yes | Surface Condition? (G/P) | Good |
