# Access Compliance Report

## Public Rights-of-Way

### (Curb Ramps)

| Intersection ID: 46370 | Main Street: DIXIE_HILLS_DR | Cross Street: STRONVAR_HOUSE_LN | Location: S |

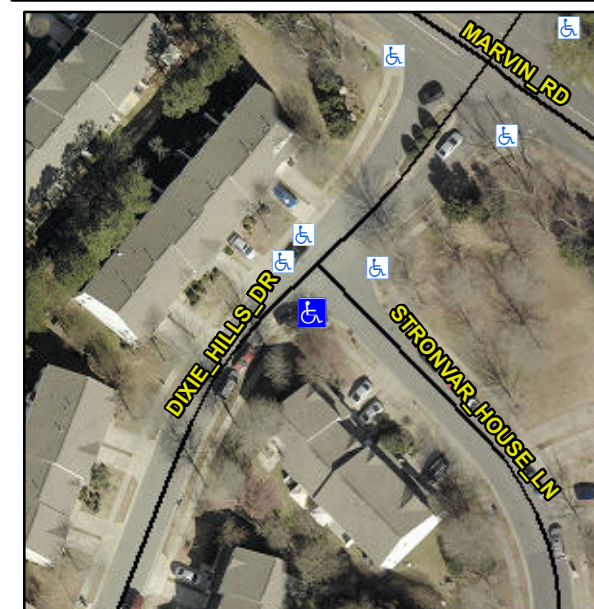
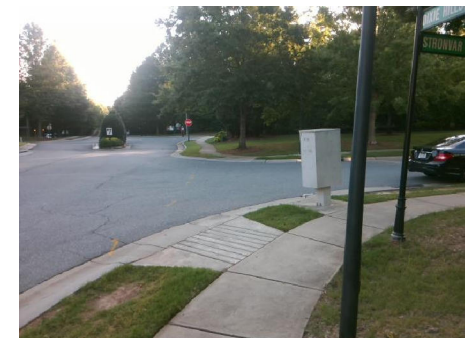
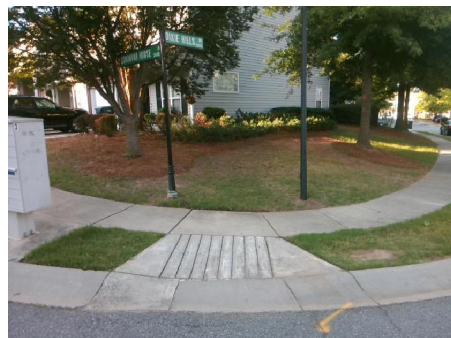
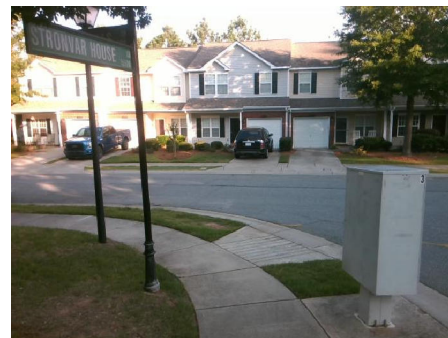
| ADA ID: 0E32EE461EDF | Ramp Type: BlendTrans1 | Initial Pass/Fail: Fail | Overall Compliance: No |

**R304.5.3**

| Compliance | Description | Data | Compliance | Description | Data |
|---|---|---|---|---|---|
| Yes | Ramp Width (in) | 48.0 | No | BlendTrans XSlope (%) | 7.4 |

**Remove & Replace Curb Ramp With Two New Directional Ramps or Equivalent.**

**\$ 3200.00**
