# Access Compliance Report

## Public Rights-of-Way

### (Curb Ramps)

Intersection ID: 17759	Main Street: PARK_RD	Cross Street: REECE_RD	Location: NE
ADA ID: 0E347F6AABB5	Ramp Type: PerpDiag	Initial Pass/Fail: Fail	Overall Compliance: No
Severity Score: 47.5			
Codes/Mitigation Info/Possible Solution		Field Measurements/Component Compliance

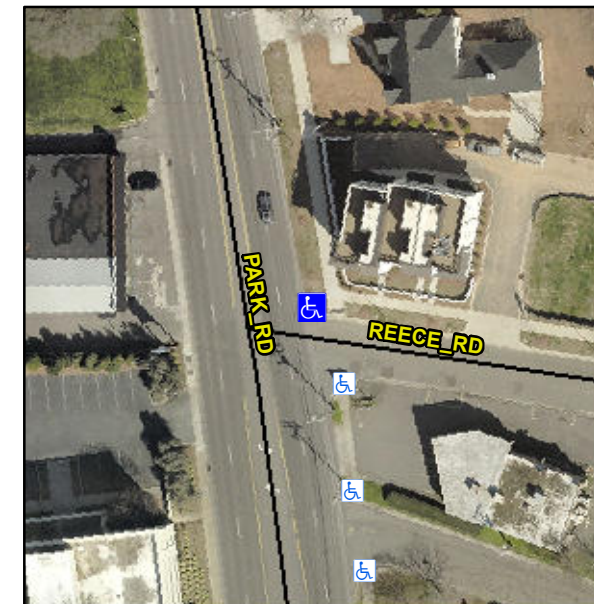
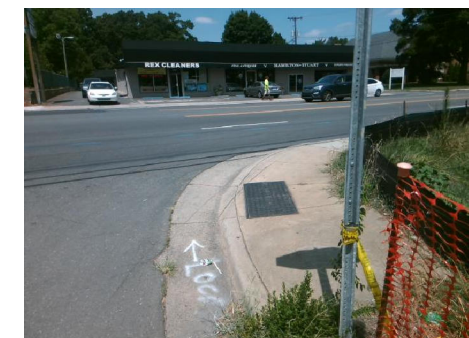
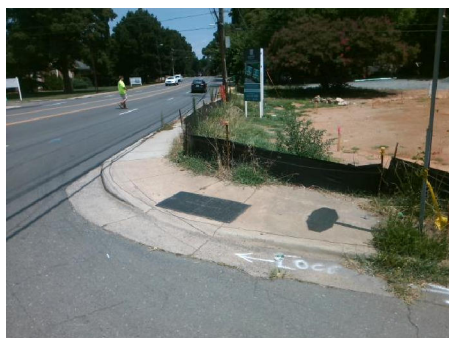
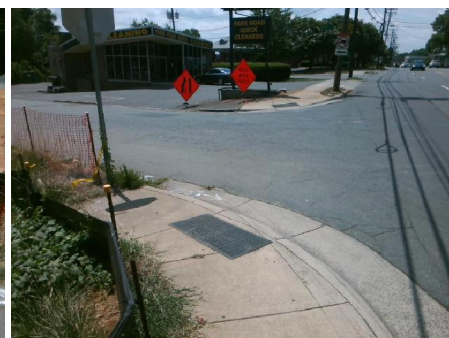
**Not Found, R304.5.1, R304.5.3**

Compliance	Description	Data	Compliance	Description	Data
N/A	Ramp Length (in)	62.0	Yes	Ramp Slope (%)	5.7
No	Ramp Width (in)	27.0	No	Ramp XSlope (%)	6.0
N/A	Flare Type LT	N/A	N/A	Flare Type RT	N/A
N/A	Flare Slope LT (%)	N/A	N/A	Flare Slope RT (%)	N/A
N/A	Flare Traversable LT?	N/A	N/A	Flare Traversable RT?	N/A
N/A	Landing Length (in)	N/A	N/A	DWS Provided?	N/A
N/A	Landing Width (in)	N/A	N/A	DWS Contrast?	N/A
N/A	Landing Slope (%)	N/A	N/A	DWS Length (in)	N/A
N/A	Landing X Slope (%)	N/A	N/A	DWS Full Width?	N/A
N/A	Landing Curb? (Y/N)	N/A	N/A	DWS Offset (in)	N/A
N/A	Shared Landing?	N/A			
N/A	Gutter Ponding?	N/A	N/A	Gutter Slope (%)	N/A
N/A	Gutter Lip Ht (in)	N/A	N/A	Gutter X Slope (%)	N/A
N/A	Painted X Walk1?	No	N/A	Painted X Walk2?	No
	X Walk 1 Direction	To W		X Walk 2 Direction	To S
N/A	X Walk 1 Width (in)	N/A	N/A	X Walk 2 Width (in)	N/A
	X Walk 1 Slope (%)	10.7		X Walk 2 Slope (%)	0.3
	X Walk 1 X Slope (%)	2.8		X Walk 2 X Slope (%)	7.4

N/A	Ramp inside XWalk1?	N/A	N/A	Ramp inside XWalk2?	N/A
	Road Slope (%)	11.9	N/A	Clear Space?	N/A
	Road X Slope (%)	5.4	N/A	Clear Space to XWalk (in)	N/A
N/A	Any Obstructions?	N/A	N/A	Storm Grate/Utility Hazard?	N/A
	Obstruction Type			Storm Grate/Utility Type	
		N/A			N/A
			Yes	Surface Condition? (G/P)	Good

**Remove & Replace Curb Ramp With Two New Directional Ramps or Equivalent.**
