# Access Compliance Report

## Public Rights-of-Way

### (Curb Ramps)

| Intersection ID: 18794 | Main Street: RANDOLPH_RD | Cross Street: REMBRANDT_CR | Location: SE |

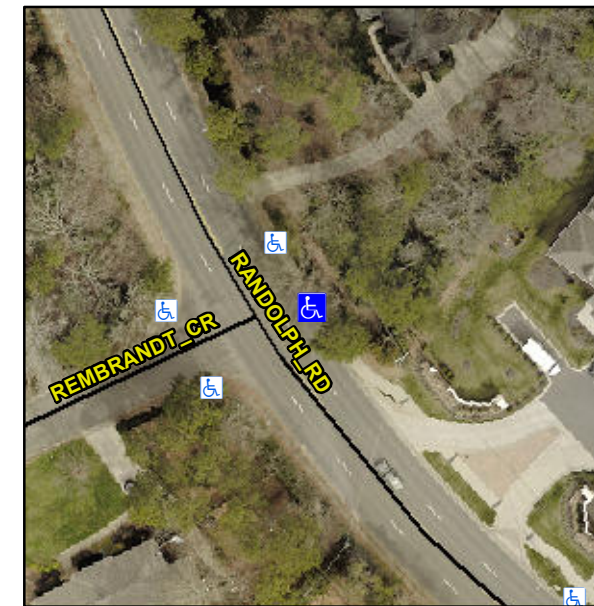
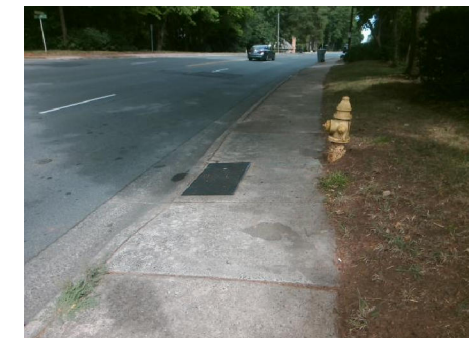
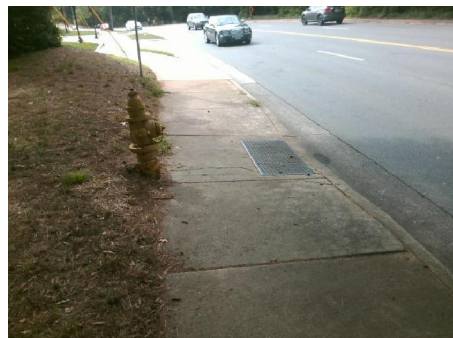
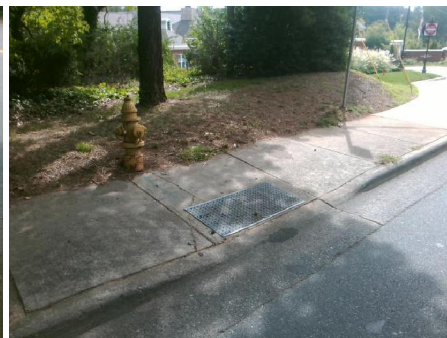
**Not Found, R304.2.2**

| Compliance | Description | Data | Compliance | Description | Data |
|---|---|---|---|---|---|
| N/A | Ramp Length (in) | 71.0 | No | Ramp Slope (%) | 8.6 |
| Yes | Ramp Width (in) | 48.0 | Yes | Ramp XSlope (%) | 1.3 |

**Remove & Replace Entire Ramp.**

Total Cost: \$ 1850.00
