# Access Compliance Report

## Public Rights-of-Way

| Intersection ID: 54364 | Main Street: GANNON_DR | Cross Street: BEREWICK_TOWN_CENTER | Location: SE |
| ADA ID: 0E3B7D77CCB1 | Ramp Type: BlendTrans1 | Initial Pass/Fail: Fail | Overall Compliance: No |

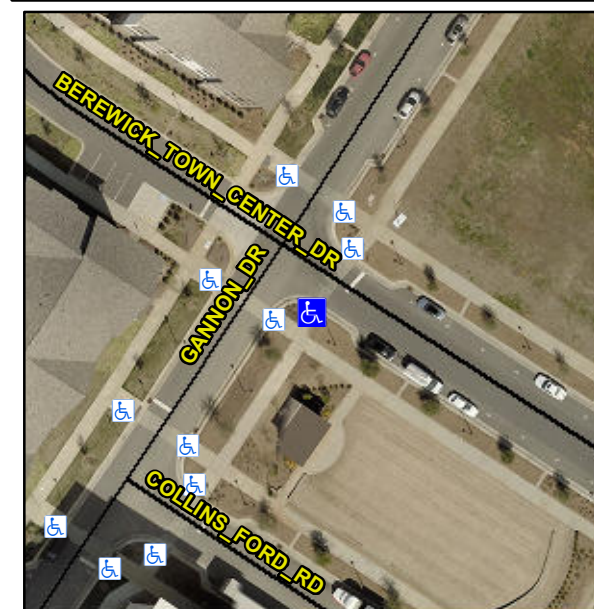
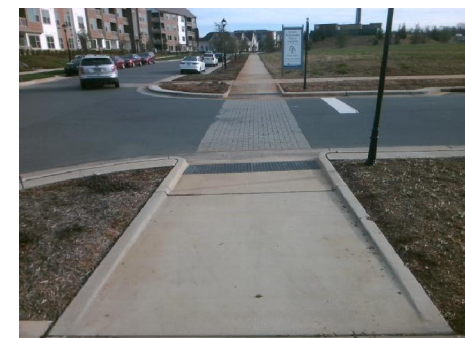
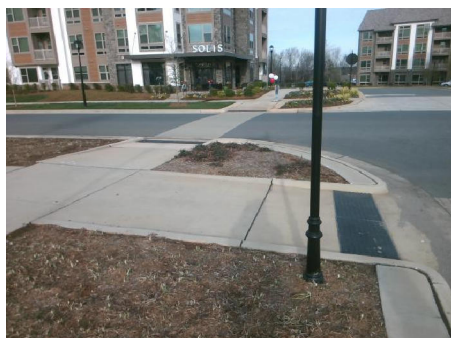
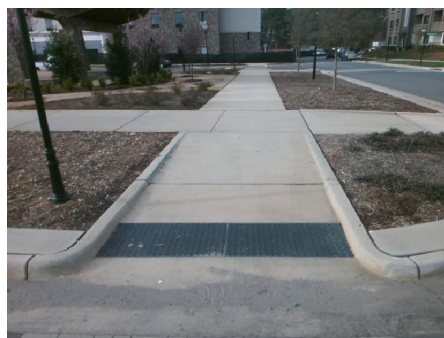
**XWALK PAVERS**

**R304.5.3**

| Compliance | Description | Data | Compliance | Description | Data |
|---|---|---|---|---|---|
| Yes | Ramp Width (in) | 94.0 | No | BlendTrans XSlope (%) | 2.5 |

**Remove & Replace Curb Ramp With Two New Directional Ramps or Equivalent.**

Total Cost: \$ 3200.00
