Access Compliance Report

Public Rights-of-Way

(Curb Ramps)

Intersection ID: 10025569	Main Street: E_W_T_HARRIS_BV	Cross Street: N/A	Location: NE
ADA ID: 0E40925CB04E	Ramp Type: PerpDiag	Initial Pass/Fail: Fail	Overall Compliance: No
Severity Score: 13.75			
Codes/Mitigation Info/Possible Solution		Field Measurements/Component Compliance

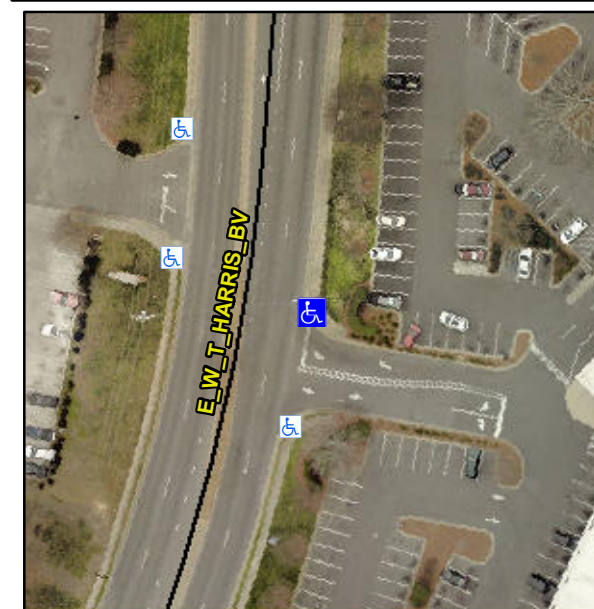
Not Found, R304.2.2, R304.5.3

Compliance	Description	Data	Compliance	Description	Data
N/A	Ramp Length (in)	70.0	No	Ramp Slope (%)	9.2
Yes	Ramp Width (in)	48.0	No	Ramp XSlope (%)	2.7
N/A	Flare Type LT	N/A	N/A	Flare Type RT	N/A
N/A	Flare Slope LT (%)	N/A	N/A	Flare Slope RT (%)	N/A
N/A	Flare Traversable LT?	N/A	N/A	Flare Traversable RT?	N/A
N/A	Landing Length (in)	N/A	N/A	DWS Provided?	N/A
N/A	Landing Width (in)	N/A	N/A	DWS Contrast?	N/A
N/A	Landing Slope (%)	N/A	N/A	DWS Length (in)	N/A
N/A	Landing X Slope (%)	N/A	N/A	DWS Full Width?	N/A
N/A	Landing Curb? (Y/N)	N/A	N/A	DWS Offset (in)	N/A
N/A	Shared Landing?	N/A			
N/A	Gutter Ponding?	N/A	N/A	Gutter Slope (%)	N/A
N/A	Gutter Lip Ht (in)	N/A	N/A	Gutter X Slope (%)	N/A
N/A	Painted X Walk1?	No	N/A	Painted X Walk2?	No
	X Walk 1 Direction	To NW		X Walk 2 Direction	To SW
N/A	X Walk 1 Width (in)	N/A	N/A	X Walk 2 Width (in)	N/A
	X Walk 1 Slope (%)	5.8		X Walk 2 Slope (%)	3.8
	X Walk 1 X Slope (%)	2.1		X Walk 2 X Slope (%)	4.6

N/A	Ramp inside XWalk1?	N/A	N/A	Ramp inside XWalk2?	N/A
	Road Slope (%)	1.1	N/A	Clear Space?	N/A
	Road X Slope (%)	3.3	N/A	Clear Space to XWalk (in)	N/A
N/A	Any Obstructions?	N/A	N/A	Storm Grate/Utility Hazard?	N/A
	Obstruction Type			Storm Grate/Utility Type	
		N/A			N/A
		Yes		Surface Condition? (G/P)	Good

Remove & Replace Curb Ramp With Two New Directional Ramps or Equivalent.
