Access Compliance Report

Public Rights-of-Way

(Curb Ramps)

Intersection ID: 11920	Main Street: FREEDOM_DR	Cross Street: WOODRUFF_PL	Location: S
ADA ID: 0E4C2AC01298	Ramp Type: Perp	Initial Pass/Fail: Fail	Overall Compliance: No
Severity Score: 8.75			
Codes/Mitigation Info/Possible Solution		Field Measurements/Component Compliance

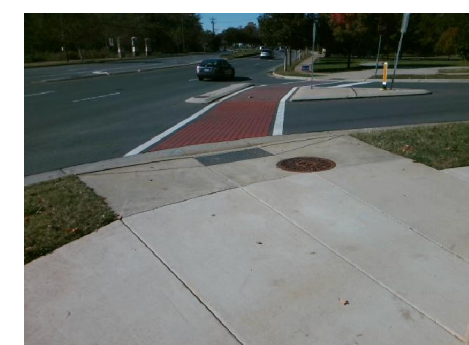
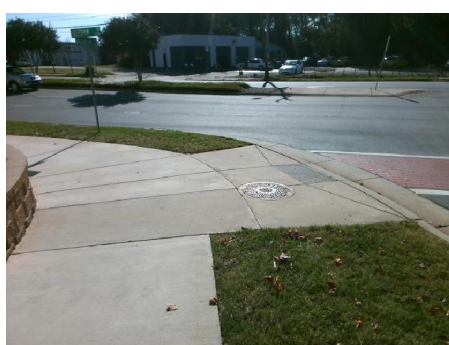
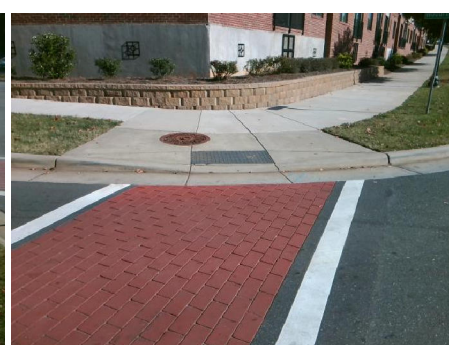
Not Found, R304.5.1

Compliance	Description	Data	Compliance	Description	Data
N/A	Ramp Length (in)	71.0	Yes	Ramp Slope (%)	5.1
No	Ramp Width (in)	42.0	Yes	Ramp XSlope (%)	1.4
N/A	Flare Type LT	N/A	N/A	Flare Type RT	N/A
N/A	Flare Slope LT (%)	N/A	N/A	Flare Slope RT (%)	N/A
N/A	Flare Traversable LT?	N/A	N/A	Flare Traversable RT?	N/A
N/A	Landing Length (in)	N/A	N/A	DWS Provided?	N/A
N/A	Landing Width (in)	N/A	N/A	DWS Contrast?	N/A
N/A	Landing Slope (%)	N/A	N/A	DWS Length (in)	N/A
N/A	Landing X Slope (%)	N/A	N/A	DWS Full Width?	N/A
N/A	Landing Curb? (Y/N)	N/A	N/A	DWS Offset (in)	N/A
N/A	Shared Landing?	N/A			
N/A	Gutter Ponding?	N/A	N/A	Gutter Slope (%)	N/A
N/A	Gutter Lip Ht (in)	N/A	N/A	Gutter X Slope (%)	N/A
N/A	Painted X Walk1?	Yes	N/A	Painted X Walk2?	N/A
	X Walk 1 Direction	To NW		X Walk 2 Direction	N/A
N/A	X Walk 1 Width (in)	92.0	N/A	X Walk 2 Width (in)	N/A
	X Walk 1 Slope (%)	3.0		X Walk 2 Slope (%)	N/A
	X Walk 1 X Slope (%)	2.7		X Walk 2 X Slope (%)	N/A

N/A	Ramp inside XWalk1?	Yes	N/A	Ramp inside XWalk2?	N/A
	Road Slope (%)	N/A	N/A	Clear Space?	N/A
	Road X Slope (%)	N/A	N/A	Clear Space to XWalk (in)	N/A
N/A	Any Obstructions?	N/A	N/A	Storm Grate/Utility Hazard?	N/A
	Obstruction Type			Storm Grate/Utility Type	
		N/A			N/A
		Yes		Surface Condition? (G/P)	Good

Possible Solutions:

Remove & Replace Entire Ramp.
