# Access Compliance Report

## Public Rights-of-Way

### (Curb Ramps)

Intersection ID: 50578	Main Street: PAPER_TREE_RD	Cross Street: BENDING_BRANCH_RD	Location: E
ADA ID: 0E4D98AB3098	Ramp Type: Perp	Initial Pass/Fail: Fail	Overall Compliance: No
Severity Score: 8.75			
Codes/Mitigation Info/Possible Solution		Field Measurements/Component Compliance

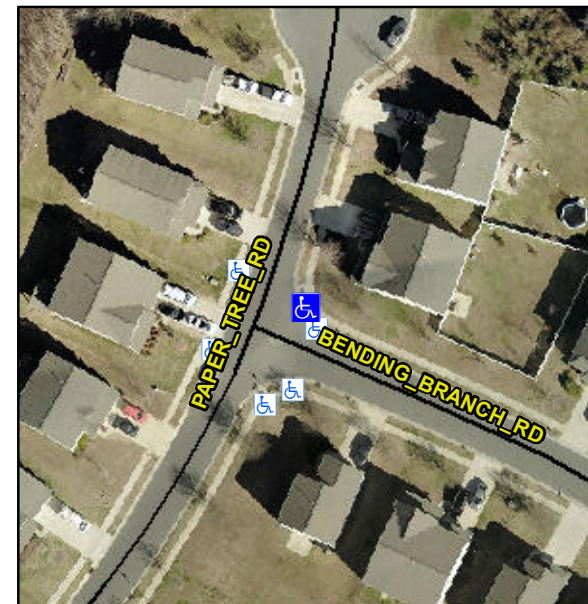
Compliance	Description	Data	Compliance	Description	Data
N/A	Ramp Length (in)	47.0	Yes	Ramp Slope (%)	8.0
No	Ramp Width (in)	47.0	Yes	Ramp XSlope (%)	1.8
N/A	Flare Type LT	N/A	N/A	Flare Type RT	N/A
N/A	Flare Slope LT (%)	N/A	N/A	Flare Slope RT (%)	N/A
N/A	Flare Traversable LT?	N/A	N/A	Flare Traversable RT?	N/A
N/A	Landing Length (in)	N/A	N/A	DWS Provided?	N/A
N/A	Landing Width (in)	N/A	N/A	DWS Contrast?	N/A
N/A	Landing Slope (%)	N/A	N/A	DWS Length (in)	N/A
N/A	Landing X Slope (%)	N/A	N/A	DWS Full Width?	N/A
N/A	Landing Curb? (Y/N)	N/A	N/A	DWS Offset (in)	N/A
N/A	Shared Landing?	N/A			
N/A	Gutter Ponding?	N/A	N/A	Gutter Slope (%)	N/A
N/A	Gutter Lip Ht (in)	N/A	N/A	Gutter X Slope (%)	N/A
N/A	Painted X Walk1?	No	N/A	Painted X Walk2?	N/A
	X Walk 1 Direction	To NW		X Walk 2 Direction	N/A
N/A	X Walk 1 Width (in)	N/A	N/A	X Walk 2 Width (in)	N/A
	X Walk 1 Slope (%)	2.5		X Walk 2 Slope (%)	N/A
	X Walk 1 X Slope (%)	1.8		X Walk 2 X Slope (%)	N/A

N/A	Ramp inside XWalk1?	N/A	N/A	Ramp inside XWalk2?	N/A
	Road Slope (%)	N/A	N/A	Clear Space?	N/A
	Road X Slope (%)	N/A	N/A	Clear Space to XWalk (in)	N/A
N/A	Any Obstructions?	N/A	N/A	Storm Grate/Utility Hazard?	N/A
	Obstruction Type			Storm Grate/Utility Type	
		N/A			N/A
			Yes	Surface Condition? (G/P)	Good

Possible Solutions:

**Remove & Replace Entire Ramp.**

**Not Found, R304.5.1**
