Access Compliance Report

Public Rights-of-Way

| Intersection ID: 2454 | Main Street: CLARKE_CREEK_PY | Cross Street: MILLSTREAM_RIDGE_DR | Location: SE |
| ADA ID: 0E637565D398 | Ramp Type: PerpDiag | Initial Pass/Fail: Fail | Overall Compliance: No |

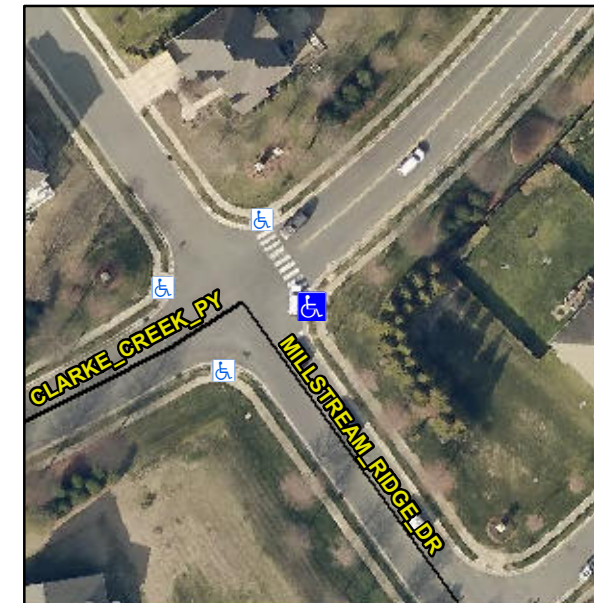
Not Found, R304.5.1

| Compliance | Description | Data | Compliance | Description | Data |
|---|---|---|---|---|---|
| No | Ramp Width (in) | 42.0 | Yes | Ramp XSlope (%) | 0.2 |

Remove & Replace Curb Ramp With Two New Directional Ramps or Equivalent.
