Access Compliance Report

Public Rights-of-Way

(Curb Ramps)

Intersection ID: 11239	Main Street: DELGANY_DR	Cross Street: MCKELVEY_ST	Location: SW
ADA ID: 0E73F6B4BE02	Ramp Type: BlendTrans1	Initial Pass/Fail: Fail	Overall Compliance: No
		Severity Score: 10

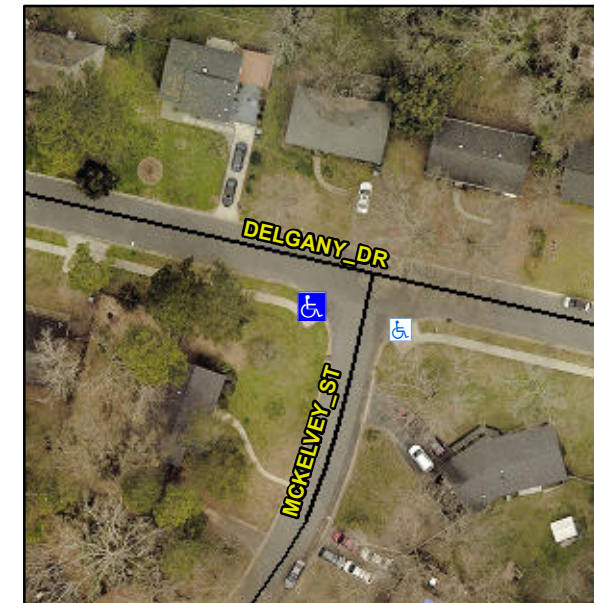
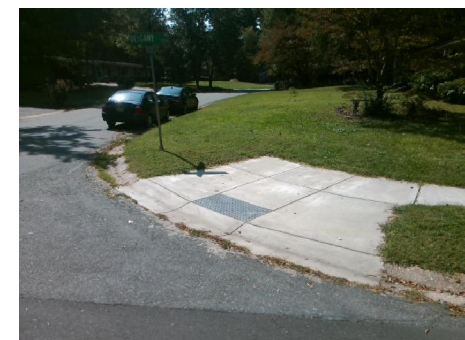
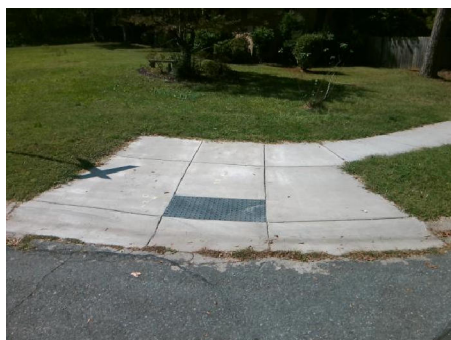
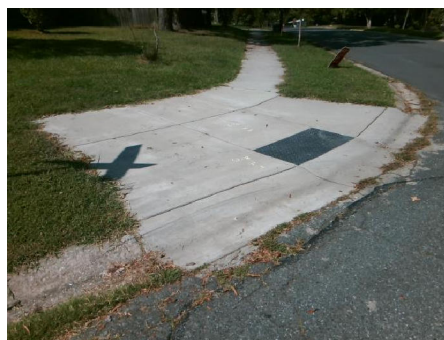
Not Found, R304.5.1, R304.5.3

Compliance	Description	Data	Compliance	Description	Data
N/A	Ramp Length (in)	74.0	Yes	BlendTrans Slope (%)	3.3
No	Ramp Width (in)	47.5	No	BlendTrans XSlope (%)	2.2
N/A	Flare Type LT	N/A	N/A	Flare Type RT	N/A
N/A	Flare Slope LT (%)	N/A	N/A	Flare Slope RT (%)	N/A
N/A	Flare Traversable LT?	N/A	N/A	Flare Traversable RT?	N/A
N/A	Landing Length (in)	N/A	N/A	DWS Provided?	N/A
N/A	Landing Width (in)	N/A	N/A	DWS Contrast?	N/A
N/A	Landing Slope (%)	N/A	N/A	DWS Length (in)	N/A
N/A	Landing X Slope (%)	N/A	N/A	DWS Full Width?	N/A
N/A	Landing Curb? (Y/N)	N/A	N/A	DWS Offset (in)	N/A
N/A	Shared Landing?	N/A			
N/A	Gutter Ponding?	N/A	N/A	Gutter Slope (%)	N/A
N/A	Gutter Lip Ht (in)	0.5	N/A	Gutter X Slope (%)	N/A
N/A	Painted X Walk1?	No	N/A	Painted X Walk2?	N/A
	X Walk 1 Direction	To E		X Walk 2 Direction	N/A
	X Walk 1 Width (in)	N/A		X Walk 2 Width (in)	N/A
	X Walk 1 Slope (%)	2.4		X Walk 2 Slope (%)	N/A
	X Walk 1 X Slope (%)	0.8		X Walk 2 X Slope (%)	N/A

N/A	Ramp inside XWalk1?	N/A	N/A	Ramp inside XWalk2?	N/A
	Road Slope (%)	0.8		Clear Space?	N/A
	Road X Slope (%)	2.4	N/A	Clear Space to XWalk (in)	N/A
N/A	Any Obstructions?	N/A	N/A	Storm Grate/Utility Hazard?	N/A
	Obstruction Type			Storm Grate/Utility Type	
		N/A			N/A
			Yes	Surface Condition? (G/P)	Good
			No	Curb Slope (%)	27.2

Remove & Replace Curb Ramp With Two New Directional Ramps or Equivalent.
