Access Compliance Report Public Rights-of-Way (Curb Ramps)

Intersection ID: 53235	Main Street: EVERGREEN_DR			Street:	DOLLY_MADISON_R	Location:	NE			
ADA ID: 0E7917116BE7				Initial Pass/Fail: Fail Overall Compliance: No					22.5	
· · · ·			minual						22.0	
Codes/Mitigation Info/Possible Solution				Field Measurements/Component Compliance Compliance Description Data Compliance Data						
DOWD HOUSE LM		Possible Solutions:		Compliance Description			Data Compliance Description			
AND FROM AND	E. M.	Remove & Replace Entire Ramp).	N/A	Ramp Length (in)	36.0		Ramp Slope (%)	10.0

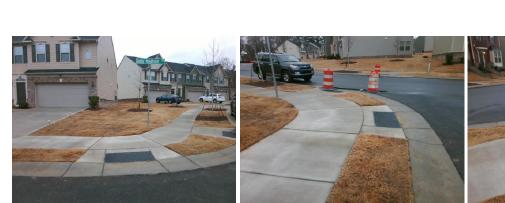
38: 1	Ribin			No	Ramp Width (in)	47.0	No	Ramp XSlope (%)	2.8	
	interna al al al			N/A	Flare Type LT	N/A	N/A	Flare Type RT	N/A	
				N/A	Flare Slope LT (%)	N/A	N/A	Flare Slope RT (%)	N/A	
				N/A	Flare Traversable LT?	N/A	N/A	Flare Traversable RT?	N/A	
				N/A	Landing Length (in)	N/A	N/A	DWS Provided?	N/A	
		Surveyor Notes:		N/A	Landing Width (in)	N/A	N/A	DWS Contrast?	N/A	
		N/A		N/A	Landing Slope (%)	N/A	N/A	DWS Length (in)	N/A	
SVERGROS	spel Lite			N/A	Landing X Slope (%)	N/A	N/A	DWS Full Width?	N/A	
	LOR I			N/A	Landing Curb? (Y/N)	N/A	N/A	DWS Offset (in)	N/A	
I There are	1 St			N/A	Shared Landing?	N/A
