# Access Compliance Report

## Public Rights-of-Way

| Intersection ID: 14342 | Main Street: LILLINGTON_AV | Cross Street: AMHERST_PL | Location: S |
| ADA ID: 0E7FD736D70D | Ramp Type: BlendTrans1 | Initial Pass/Fail: Pass | Overall Compliance: Yes |

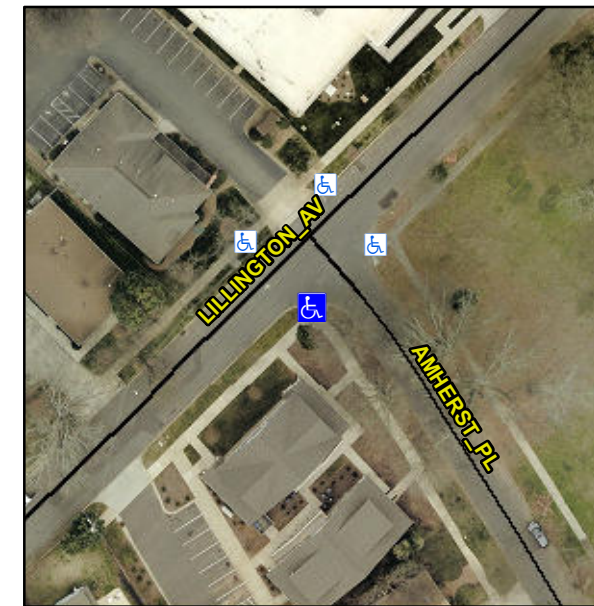
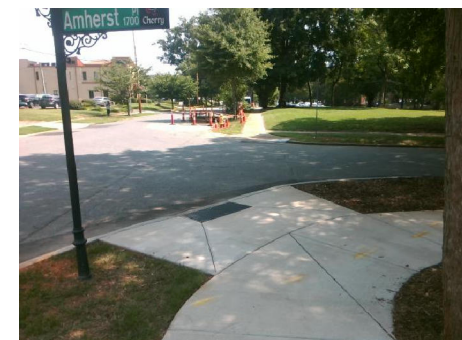
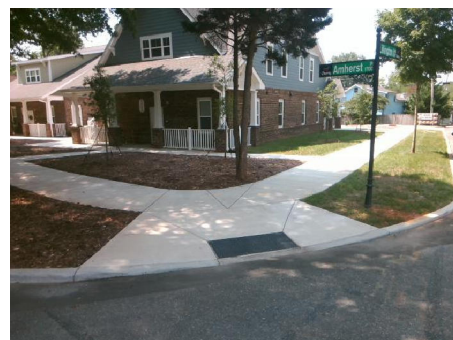
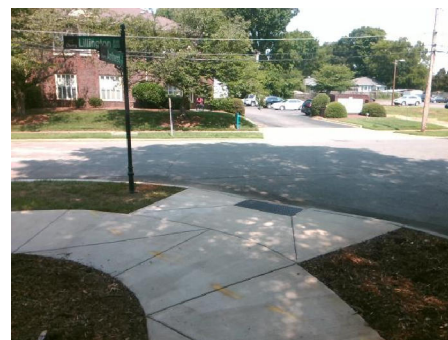
| Severity Score: 0 | | | |

| Compliance | Description | Data | Compliance | Description | Data |
|---|---|---|---|---|---|
| N/A | Ramp Length (in) | 79.0 | Yes | BlendTrans Slope (%) | 3.4 |
| Yes | Ramp Width (in) | 48.0 | Yes | BlendTrans XSlope (%) | 1.2 |
| Yes | Landing Length (in) | 60.0 | Yes | DWS Provided? | Yes |
| Yes | Landing Width (in) | 48.0 | Yes | DWS Contrast? | Yes |
| Yes | Landing Slope (%) | 0.8 | Yes | DWS Length (in) | 24.0 |
| Yes | Landing X Slope (%) | 0.2 | Yes | DWS Full Width? | Yes |
| Yes | Gutter Ponding? | No | Yes | Gutter Slope (%) | 3.7 |
| Yes | Gutter Lip Ht (in) | 0.0 | Yes | Gutter X Slope (%) | 1.0 |
| Yes | Any Obstructions? | No | Yes | Storm Grate/Utility Hazard? | No |
| | | | Yes | Surface Condition? (G/P) | Good |
| | | | Yes | Curb Slope (%) | 2.7 |

Possible Solutions:

N/A
