# Access Compliance Report

## Public Rights-of-Way

### (Curb Ramps)

| Intersection ID: 30383 | Main Street: BELLSOUTH_DR | Cross Street: CENTRAL_AV | Location: | N |

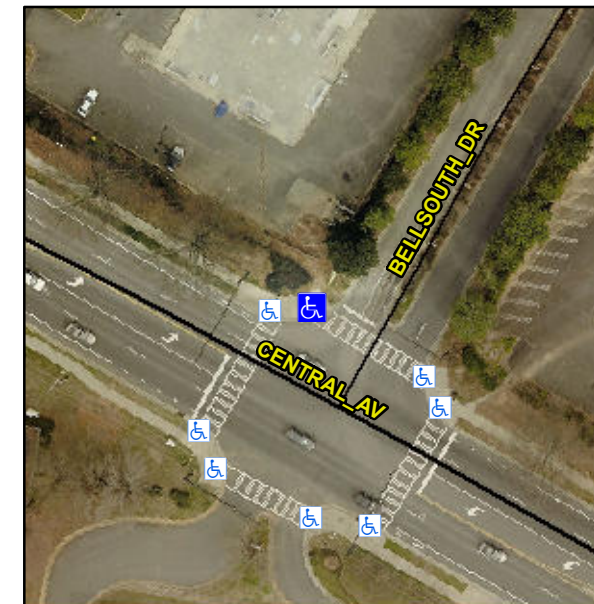
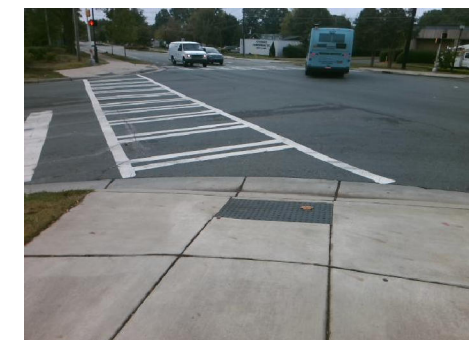
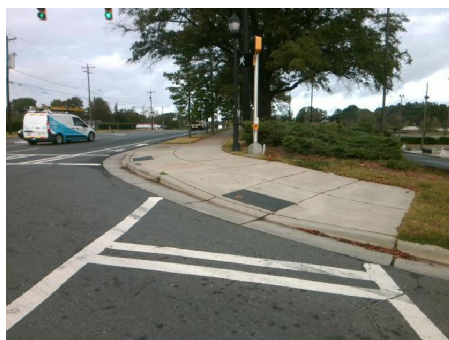
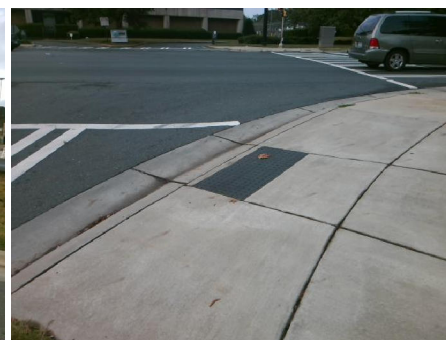
| ADA ID: 0E817FD633EC | Ramp Type: Perp | Initial Pass/Fail: Fail | Overall Compliance: No | Severity Score: 25 |

**Not Found, R304.5.3**

| Compliance | Description | Data | Compliance | Description | Data |
|---|---|---|---|---|---|
| N/A | Ramp Length (in) | 61.0 | Yes | Ramp Slope (%) | 7.7 |
| Yes | Ramp Width (in) | 48.0 | No | Ramp XSlope (%) | 11.2 |

**Remove & Replace Entire Ramp.**

Total Cost: \$ 1850.00
