# Access Compliance Report

## Public Rights-of-Way

### (Curb Ramps)

| Intersection ID: 10035049 | Main Street: PROVIDENCE_RD | Cross Street: N/A | Location: N |

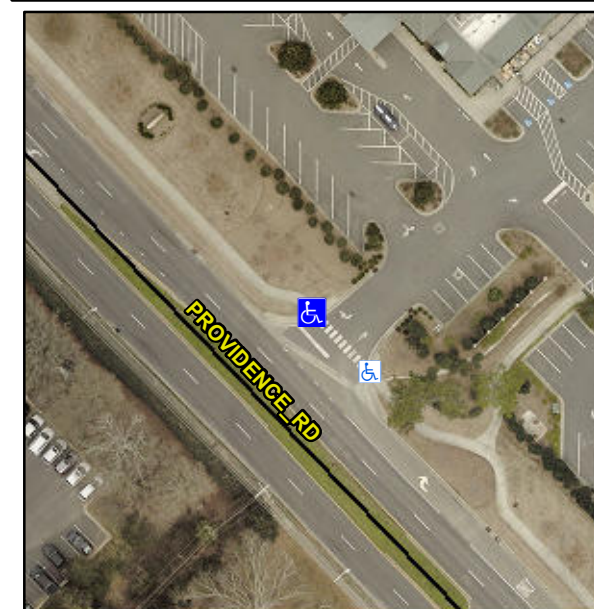
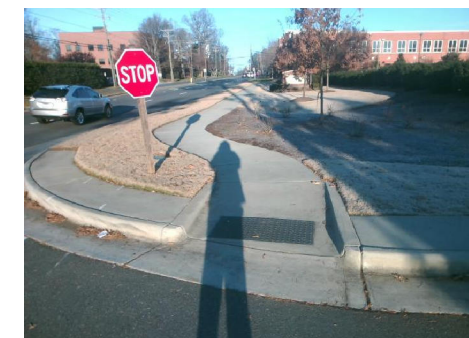
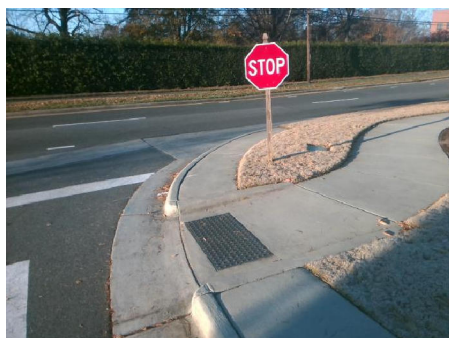
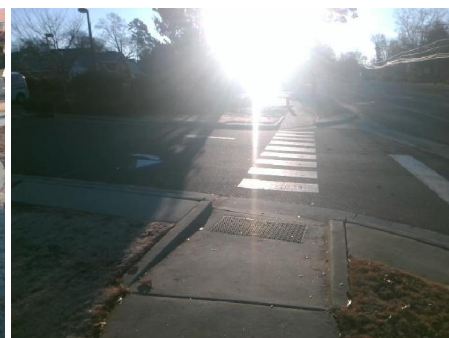
| ADA ID: 0E83368986C4 | Ramp Type: Directional1 | Initial Pass/Fail: Fail | Overall Compliance: No |

**R304.5.3**

| Compliance | Description | Data | Compliance | Description | Data |
|---|---|---|---|---|---|
| No | Ramp XSlope (%) | 2.5 | | | |

**Remove & Replace Entire Ramp.**

\$ 1600.00
