# Access Compliance Report

## Public Rights-of-Way

| Intersection ID: 46344 | Main Street: BENNETT_NEELY_LN | Cross Street: STREAM_BANK_DR | Location: NE |
| ADA ID: 0E8DB08D472B | Ramp Type: PerpDiag | Initial Pass/Fail: Fail | Overall Compliance: No |

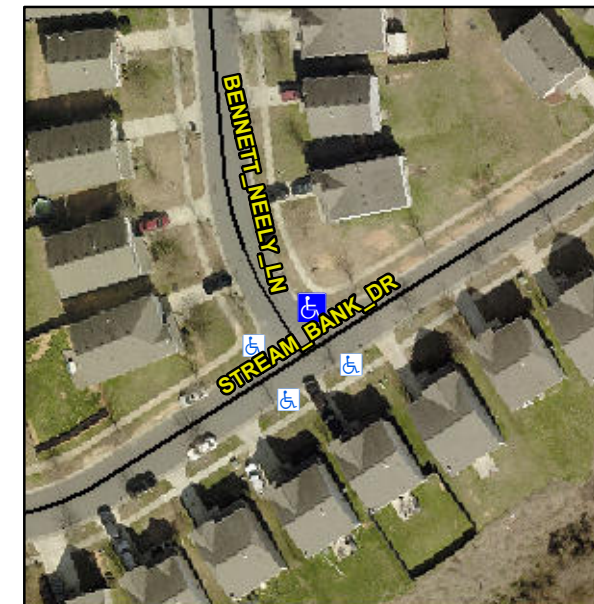
**Not Found, R304.5.1, R304.5.3**

| Compliance | Description | Data | Compliance | Description | Data |
|---|---|---|---|---|---|
| N/A | Ramp Length (in) | 86.0 | Yes | Ramp Slope (%) | 6.4 |
| No | Ramp Width (in) | 47.0 | No | Ramp XSlope (%) | 6.0 |

**Remove & Replace Curb Ramp With Two New Directional Ramps or Equivalent.**
