# Access Compliance Report

## Public Rights-of-Way

### (Curb Ramps)

Intersection ID: 53281	Main Street: BENFIELD_RD	Cross Street: CRAVEN_THOMAS_RD	Location: E
ADA ID: 0E92E85FE819	Ramp Type: Perp	Initial Pass/Fail: Fail	Overall Compliance: No
Severity Score: 33.75			
Codes/Mitigation Info/Possible Solution		Field Measurements/Component Compliance

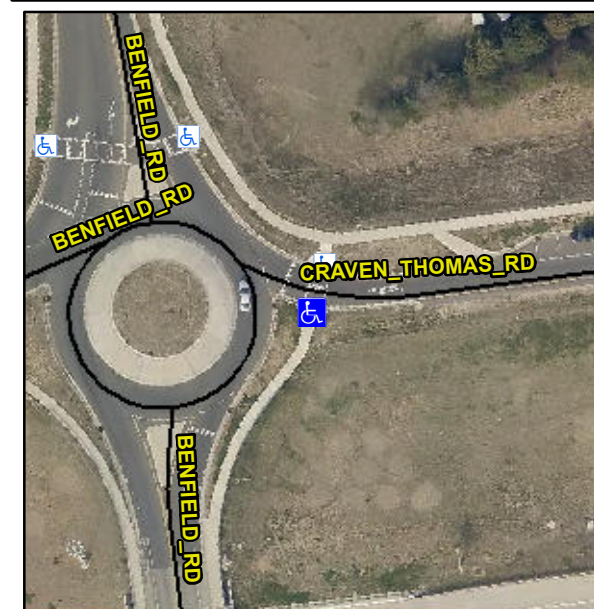
Compliance	Description	Data	Compliance	Description	Data
N/A	Ramp Length (in)	92.0	No	Ramp Slope (%)	13.8
No	Ramp Width (in)	47.5	Yes	Ramp XSlope (%)	1.5
N/A	Flare Type LT	N/A	N/A	Flare Type RT	N/A
N/A	Flare Slope LT (%)	N/A	N/A	Flare Slope RT (%)	N/A
N/A	Flare Traversable LT?	N/A	N/A	Flare Traversable RT?	N/A
N/A	Landing Length (in)	N/A	N/A	DWS Provided?	N/A
N/A	Landing Width (in)	N/A	N/A	DWS Contrast?	N/A
N/A	Landing Slope (%)	N/A	N/A	DWS Length (in)	N/A
N/A	Landing X Slope (%)	N/A	N/A	DWS Full Width?	N/A
N/A	Landing Curb? (Y/N)	N/A	N/A	DWS Offset (in)	N/A
N/A	Shared Landing?	N/A			
N/A	Gutter Ponding?	N/A	N/A	Gutter Slope (%)	N/A
N/A	Gutter Lip Ht (in)	N/A	N/A	Gutter X Slope (%)	N/A
N/A	Painted X Walk1?	Yes	N/A	Painted X Walk2?	N/A
	X Walk 1 Direction	To N		X Walk 2 Direction	N/A
N/A	X Walk 1 Width (in)	104.0	N/A	X Walk 2 Width (in)	N/A
	X Walk 1 Slope (%)	0.6		X Walk 2 Slope (%)	N/A
	X Walk 1 X Slope (%)	1.8		X Walk 2 X Slope (%)	N/A

N/A	Ramp inside XWalk1?	Yes	N/A	Ramp inside XWalk2?	N/A
	Road Slope (%)	N/A	N/A	Clear Space?	N/A
	Road X Slope (%)	N/A	N/A	Clear Space to XWalk (in)	N/A
N/A	Any Obstructions?	N/A	N/A	Storm Grate/Utility Hazard?	N/A
	Obstruction Type			Storm Grate/Utility Type	
		N/A			N/A
		Yes		Surface Condition? (G/P)	Good

Possible Solutions:

**Remove & Replace Entire Ramp.**

**R304.5.1, R304.2.2**

Total Cost: \$ 1850.00
