## **Access Compliance Report Public Rights-of-Way** (Curb Ramps)

Intersection ID: 44347 Main Street: CHOATE CR Cross Street: STONE\_ARBOR\_WY Location: ADA ID: 0E9448BEBF81 Ramp Type: PerpDiag Initial Pass/Fail: Fail **Overall Compliance: No** Severity Score: 21.25

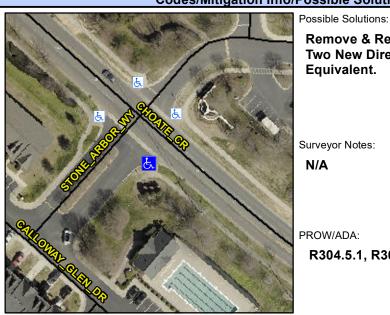
Field Measurements/Component Compliance						
Compliance Description		Data	Comp	liance	Description	Data
N/A	Ramp Length (in)	96.0	No	Ramp	Slope (%)	11.1
No	Ramp Width (in)	41.0	Yes	Ramp	XSlope (%)	0.9
N/A	Flare Type LT	N/A	N/A	Flare Type RT		N/A
N/A	Flare Slope LT (%)	N/A	N/A	Flare	Slope RT (%)	N/A
N/A	Flare Traversable LT?	N/A	N/A	Flare	Traversable RT?	N/A
N/A	Landing Length (in)	N/A	N/A	DWS	Provided?	N/A
N/A	Landing Width (in)	N/A	N/A	DWS	Contrast?	N/A
N/A	Landing Slope (%)	N/A	N/A	DWS	Length (in)	N/A
N/A	Landing X Slope (%)	N/A	N/A	DWS	Full Width?	N/A
N/A	Landing Curb? (Y/N)	N/A	N/A	DWS	Offset (in)	N/A
N/A	Shared Landing?	N/A				
N/A	Gutter Ponding?	N/A	N/A	Gutte	r Slope (%)	N/A
N/A	Gutter Lip Ht (in)	N/A	N/A	Gutte	r X Slope (%)	N/A
N/A	Painted X Walk1?	No	N/A	Painte	ed X Walk2?	No
	X Walk 1 Direction	To NE		X Wa	lk 2 Direction	To NW
N/A	X Walk 1 Width (in)	N/A	N/A	X Wa	lk 2 Width (in)	N/A
	X Walk 1 Slope (%)	1.6		X Wa	lk 2 Slope (%)	0.8

X Walk 1 X Slope (%)	1.6		X Wa	lk 2 X Slope (%)	0.7
N/A	Ramp inside XWalk1?	N/A	N/A	Ramp	inside XWalk2?	N/A
	Road Slope (%)	1.5	N/A	Clear	Space?	N/A
	Road X Slope (%)	1.7	N/A	Clear	Space to XWalk (in)	N/A
N/A	Any Obstructions?	N/A	N/A	Storm	Grate/Utility Hazard?	N/A
	Obstruction Type			Storm	Grate/Utility Type	
		N/A				N/A
			Yes	Surfa	ce Condition? (G/P)	Good

**CHOATE CR** Street 1 Name Stop Condition-Street 2 None STONE ARBOR WY Street 2 Name Stop Condition-Street 1 StopSign Remove & Replace Curb Ramp With Two New Directional Ramps or Equivalent.

R304.5.1, R304.2.2

3200.00
