Access Compliance Report

Public Rights-of-Way

(Curb Ramps)

Intersection ID: 10034399	Main Street: PIEDMONT_PARK_DR	Cross Street: AUDUBON_PARK_DR	Location: S
ADA ID: 0E957972E5BD	Ramp Type: Directional1	Initial Pass/Fail: Fail	Overall Compliance: No
Severity Score: 1.25			
Codes/Mitigation Info/Possible Solution		Field Measurements/Component Compliance

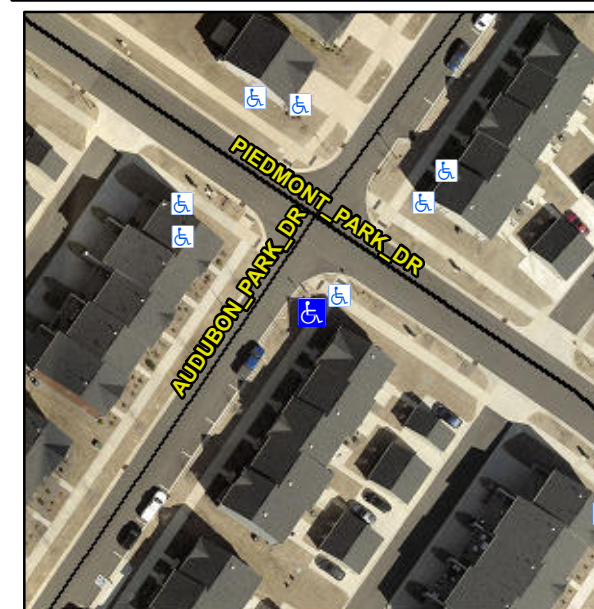
Compliance	Description	Data	Compliance	Description	Data
N/A	Ramp Length (in)	79.0	N/A	Grade Break?	N/A
Yes	Ramp Width (in)	69.0	N/A	Grade Break Slope (%)	0.0
Yes	Ramp Slope (%)	6.6	N/A	Grade Break XSlope (%)	0.0
No	Ramp XSlope (%)	3.4			
N/A	Flare Type LT	N/A	N/A	Flare Type RT	N/A
N/A	Flare Slope LT (%)	N/A	N/A	Flare Slope RT (%)	0.0
N/A	Flare Traversable LT?	N/A	N/A	Flare Traversable RT?	N/A
N/A	Landing Length (in)	0.0	N/A	DWS Provided?	N/A
N/A	Landing Width (in)	0.0	N/A	DWS Contrast?	N/A
N/A	Landing Slope (%)	0.0	N/A	DWS Length (in)	N/A
N/A	Landing X Slope (%)	0.0	N/A	DWS Full Width?	N/A
N/A	Landing Curb? (Y/N)	N/A	N/A	DWS Offset LT (in)	N/A
N/A	Shared Landing?	N/A	N/A	DWS Offset RT (in)	N/A
N/A	Gutter Ponding?	0.0	N/A	Gutter Slope (%)	N/A
N/A	Gutter Lip Ht (in)	0.0	N/A	Gutter X Slope (%)	N/A
N/A	Painted X Walk1?	No		Road Slope (%)	5.8
	X Walk 1 Direction	To NW		Road X Slope (%)	3.4
	X Walk 1 Width (in)	N/A		Clear Space?	N/A

X Walk 1 Slope (%)	5.8	N/A	Clear Space to XWalk (in)	N/A
	X Walk 1 X Slope (%)	3.4	N/A	Storm Grate/Utility Hazard?	N/A
N/A	Ramp inside XWalk1?	N/A		Storm Grate/Utility Type	
N/A	Any Obstructions?	N/A			N/A
	Obstruction Type		Yes	Surface Condition? (G/P)	Good
			N/A	Curb Slope (%)	10.5

Possible Solutions:

Remove & Replace Entire Ramp.

R304.5.3

\$ 1600.00
