Access Compliance Report

Public Rights-of-Way

(Curb Ramps)

Intersection ID: 10012	Main Street: ATMORE_ST	Cross Street: THE_PLAZA	Location: NE
ADA ID: 0E9AA7DE0892	Ramp Type: PerpDiag	Initial Pass/Fail: Pass	Overall Compliance: No
			Severity Score: 17.75

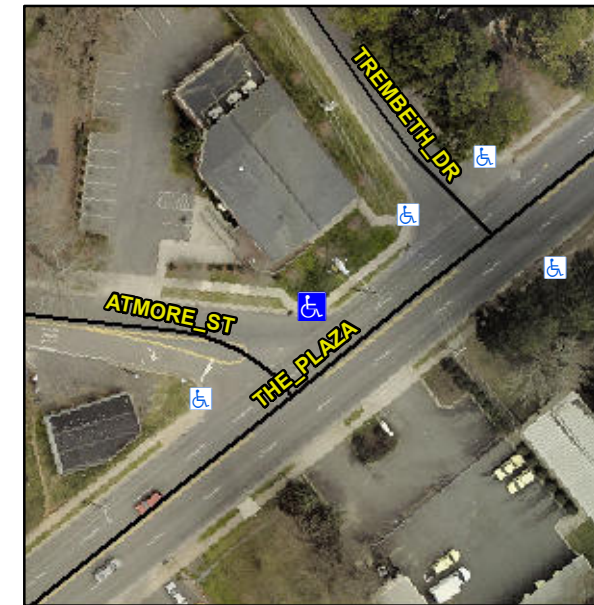
Not Found, R304.5.3, R304.2.1, R304.2.2-Perp, R304.3.2-Para, R302.7.2

Compliance	Description	Data	Compliance	Description	Data
N/A	Ramp Length (in)	66.5	Yes	Ramp Slope (%)	8.1
Yes	Ramp Width (in)	48.0	No	Ramp XSlope (%)	4.0
N/A	Flare Type LT	Sloped	N/A	Flare Type RT	N/A
N/A	Flare Slope LT (%)	0.1	Yes	Flare Slope RT (%)	5.3
N/A	Flare Traversable LT?	Yes	N/A	Flare Traversable RT?	Yes
No	Landing Length (in)	N/A	Yes	DWS Provided?	Yes
No	Landing Width (in)	N/A	Yes	DWS Contrast?	Yes
No	Landing Slope (%)	N/A	Yes	DWS Length (in)	24.5
No	Landing X Slope (%)	N/A	Yes	DWS Full Width?	Yes
N/A	Landing Curb? (Y/N)	No	Yes	DWS Offset (in)	0.0
N/A	Shared Landing?	N/A			
Yes	Gutter Ponding?	No	Yes	Gutter Slope (%)	3.3
No	Gutter Lip Ht (in)	0.5	Yes	Gutter X Slope (%)	1.3
N/A	Painted X Walk1?	No	N/A	Painted X Walk2?	No
	X Walk 1 Direction	To SW		X Walk 2 Direction	To SE
N/A	X Walk 1 Width (in)	N/A	N/A	X Walk 2 Width (in)	N/A
	X Walk 1 Slope (%)	1.5		X Walk 2 Slope (%)	3.4
	X Walk 1 X Slope (%)	2.8		X Walk 2 X Slope (%)	0.0

N/A	Ramp inside XWalk1?	N/A	N/A	Ramp inside XWalk2?	N/A
	Road Slope (%)	1.5	N/A	Clear Space?	Yes
	Road X Slope (%)	1.1	N/A	Clear Space to XWalk (in)	N/A
Yes	Any Obstructions?	No	Yes	Storm Grate/Utility Hazard?	No
	Obstruction Type			Storm Grate/Utility Type	
		N/A			N/A
			Yes	Surface Condition? (G/P)	Good

Remove & Replace Curb Ramp With Two New Directional Ramps or Equivalent.

Total Cost: \$ 3200.00
