Access Compliance Report

Public Rights-of-Way

(Curb Ramps)

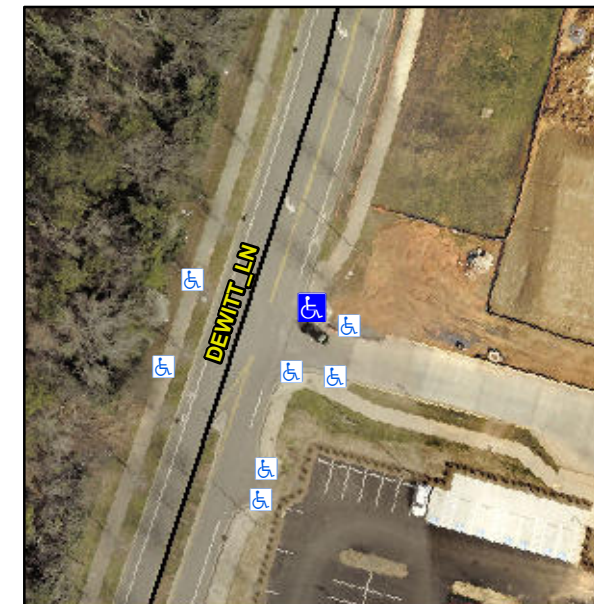
Intersection ID: 10024872	Main Street: DEWITT_LN	Cross Street: N/A	Location: NE
ADA ID: 0EA551DF309C	Ramp Type: Perp	Initial Pass/Fail: Fail	Overall Compliance: No
Severity Score: 10			
Codes/Mitigation Info/Possible Solution		Field Measurements/Component Compliance

Not Found, R304.5.1

Compliance	Description	Data	Compliance	Description	Data
N/A	Ramp Length (in)	96.0	Yes	Ramp Slope (%)	6.3
No	Ramp Width (in)	43.0	Yes	Ramp XSlope (%)	2.1
N/A	Flare Type LT	N/A	N/A	Flare Type RT	N/A
N/A	Flare Slope LT (%)	N/A	N/A	Flare Slope RT (%)	N/A
N/A	Flare Traversable LT?	N/A	N/A	Flare Traversable RT?	N/A
N/A	Landing Length (in)	N/A	N/A	DWS Provided?	N/A
N/A	Landing Width (in)	N/A	N/A	DWS Contrast?	N/A
N/A	Landing Slope (%)	N/A	N/A	DWS Length (in)	N/A
N/A	Landing X Slope (%)	N/A	N/A	DWS Full Width?	N/A
N/A	Landing Curb? (Y/N)	N/A	N/A	DWS Offset (in)	N/A
N/A	Shared Landing?	N/A			
N/A	Gutter Ponding?	N/A	N/A	Gutter Slope (%)	N/A
N/A	Gutter Lip Ht (in)	N/A	N/A	Gutter X Slope (%)	N/A
N/A	Painted X Walk1?	No	N/A	Painted X Walk2?	N/A
	X Walk 1 Direction	To NW		X Walk 2 Direction	N/A
N/A	X Walk 1 Width (in)	N/A	N/A	X Walk 2 Width (in)	N/A
	X Walk 1 Slope (%)	0.6		X Walk 2 Slope (%)	N/A
	X Walk 1 X Slope (%)	2.5		X Walk 2 X Slope (%)	N/A

Remove & Replace Entire Ramp.
