Access Compliance Report Public Rights-of-Way (Curb Ramps)

Intersection ID: 44906 Main Street: OAK DR **Cross Street: HAZELCROFT LN** Location: SW **ADA ID: 0EAB929EE6B9** Ramp Type: PerpDiag Initial Pass/Fail: Fail **Overall Compliance: No Severity Score:** 72.5

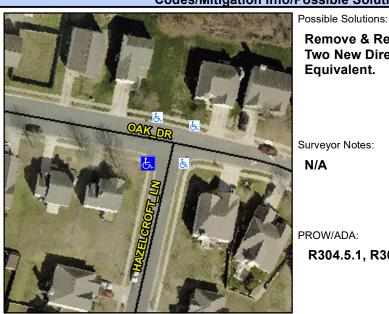
Compliance Description D		Data	Comp	liance Description	Data
N/A	Ramp Length (in)	46.0	No	Ramp Slope (%)	8.7
No	Ramp Width (in)	26.0	No	Ramp XSlope (%)	12.2
N/A	Flare Type LT	N/A	N/A	Flare Type RT	N/A
N/A	Flare Slope LT (%)	N/A	N/A	Flare Slope RT (%)	N/A
N/A	Flare Traversable LT?	N/A	N/A	Flare Traversable RT?	N/A
N/A	Landing Length (in)	N/A	N/A	DWS Provided?	N/A
N/A	Landing Width (in)	N/A	N/A	DWS Contrast?	N/A
N/A	Landing Slope (%)	N/A	N/A	DWS Length (in)	N/A
N/A	Landing X Slope (%)	N/A	N/A	DWS Full Width?	N/A
N/A	Landing Curb? (Y/N)	N/A	N/A	DWS Offset (in)	N/A
N/A	Shared Landing?	N/A			
N/A	Gutter Ponding?	N/A	N/A	Gutter Slope (%)	N/A
N/A	Gutter Lip Ht (in)	N/A	N/A	Gutter X Slope (%)	N/A
N/A	Painted X Walk1?	No	N/A	Painted X Walk2?	No
	X Walk 1 Direction	То Е		X Walk 2 Direction	To N
N/A	X Walk 1 Width (in)	N/A	N/A	X Walk 2 Width (in)	N/A
	X Walk 1 Slope (%)	3.3		X Walk 2 Slope (%)	5.5
	X Walk 1 X Slope (%)	5.8		X Walk 2 X Slope (%)	0.2

N/A	Ramp inside XWalk1?	N/A	N/A	Ramp inside XWalk2?	N/A
	Road Slope (%)	8.3	N/A	Clear Space?	N/A
	Road X Slope (%)	5.8	N/A	Clear Space to XWalk (in)	N/A
N/A	Any Obstructions?	N/A	N/A	Storm Grate/Utility Hazard?	N/A
	Obstruction Type			Storm Grate/Utility Type	
		N/A			N/A
			Yes	Surface Condition? (G/P)	Good

HAZELCROFT LI Street 1 Name Stop Condition-Street 2 StopSign Street 2 Name OAK DI Stop Condition-Street 1 None Remove & Replace Curb Ramp With Two New Directional Ramps or Equivalent.

4.5.1, R304.2.2, R304.5.3

Total Cost: 3200.00
