Access Compliance Report

Public Rights-of-Way

(Curb Ramps)

Intersection ID: 16323	Main Street: COMMODORE_ST	Cross Street: DORIS_AV	Location:	S
ADA ID: 0EB28AB94E70	Ramp Type: Perp	Initial Pass/Fail: Fail	Overall Compliance: No	Severity Score: 10
Codes/Mitigation Info/Possible Solution		Field Measurements/Component Compliance

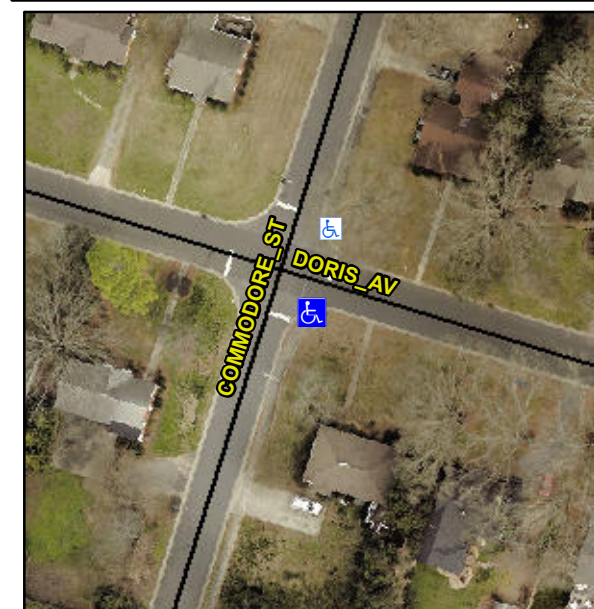
Not Found, R304.5.1, R304.5.3

Compliance	Description	Data	Compliance	Description	Data
N/A	Ramp Length (in)	26.0	Yes	Ramp Slope (%)	6.6
No	Ramp Width (in)	47.0	No	Ramp XSlope (%)	2.2
N/A	Flare Type LT	N/A	N/A	Flare Type RT	N/A
N/A	Flare Slope LT (%)	N/A	N/A	Flare Slope RT (%)	N/A
N/A	Flare Traversable LT?	N/A	N/A	Flare Traversable RT?	N/A
N/A	Landing Length (in)	N/A	N/A	DWS Provided?	N/A
N/A	Landing Width (in)	N/A	N/A	DWS Contrast?	N/A
N/A	Landing Slope (%)	N/A	N/A	DWS Length (in)	N/A
N/A	Landing X Slope (%)	N/A	N/A	DWS Full Width?	N/A
N/A	Landing Curb? (Y/N)	N/A	N/A	DWS Offset (in)	N/A
N/A	Shared Landing?	N/A			
N/A	Gutter Ponding?	N/A	N/A	Gutter Slope (%)	N/A
N/A	Gutter Lip Ht (in)	N/A	N/A	Gutter X Slope (%)	N/A
N/A	Painted X Walk1?	No	N/A	Painted X Walk2?	N/A
	X Walk 1 Direction	To NE		X Walk 2 Direction	N/A
N/A	X Walk 1 Width (in)	N/A	N/A	X Walk 2 Width (in)	N/A
	X Walk 1 Slope (%)	6.5		X Walk 2 Slope (%)	N/A
	X Walk 1 X Slope (%)	0.2		X Walk 2 X Slope (%)	N/A

Remove & Replace Entire Ramp.
