Access Compliance Report

Public Rights-of-Way

(Curb Ramps)

Intersection ID: 44264	Main Street: ISAAC_HUNTER_DR	Cross Street: LAWING_SCHOOL_RD	Location: S
ADA ID: 0EB7DF3140A9	Ramp Type: Perp	Initial Pass/Fail: Fail	Overall Compliance: No
Codes/Mitigation Info/Possible Solution		Field Measurements/Component Compliance	
Severity Score: 33.75

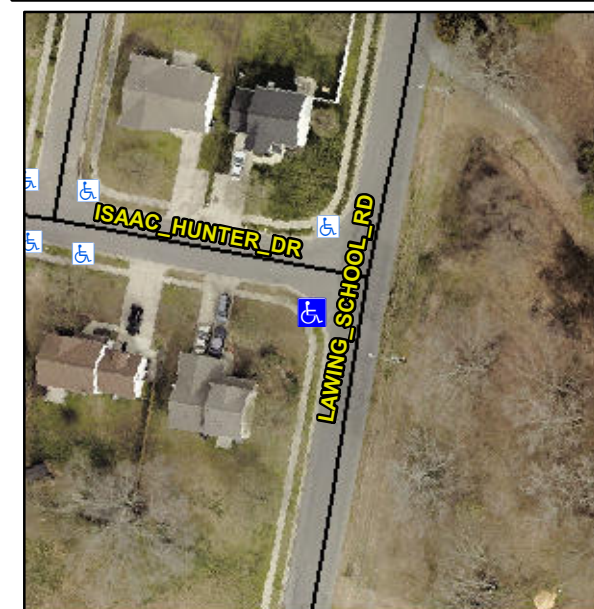
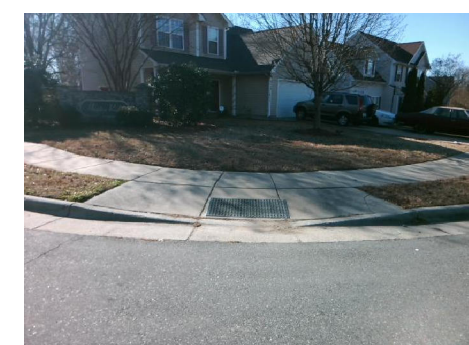
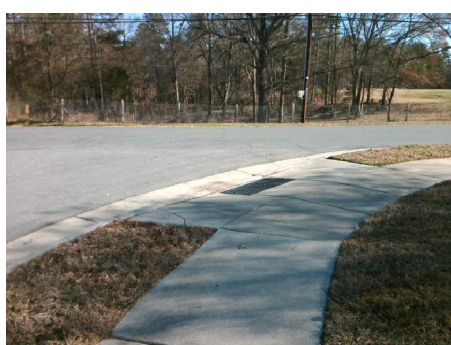
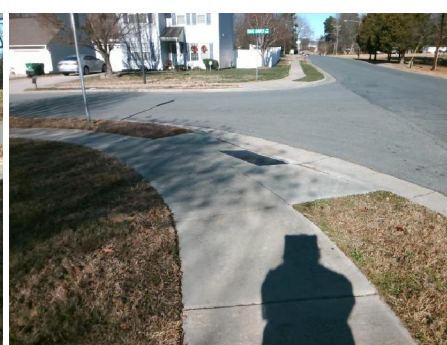
Not Found, R304.5.1, R304.2.2

Compliance	Description	Data	Compliance	Description	Data
N/A	Ramp Length (in)	47.0	No	Ramp Slope (%)	13.0
No	Ramp Width (in)	41.0	Yes	Ramp XSlope (%)	1.7
N/A	Flare Type LT	N/A	N/A	Flare Type RT	N/A
N/A	Flare Slope LT (%)	N/A	N/A	Flare Slope RT (%)	N/A
N/A	Flare Traversable LT?	N/A	N/A	Flare Traversable RT?	N/A
N/A	Landing Length (in)	N/A	N/A	DWS Provided?	N/A
N/A	Landing Width (in)	N/A	N/A	DWS Contrast?	N/A
N/A	Landing Slope (%)	N/A	N/A	DWS Length (in)	N/A
N/A	Landing X Slope (%)	N/A	N/A	DWS Full Width?	N/A
N/A	Landing Curb? (Y/N)	N/A	N/A	DWS Offset (in)	N/A
N/A	Shared Landing?	N/A			
N/A	Gutter Ponding?	N/A	N/A	Gutter Slope (%)	N/A
N/A	Gutter Lip Ht (in)	N/A	N/A	Gutter X Slope (%)	N/A
N/A	Painted X Walk1?	No	N/A	Painted X Walk2?	N/A
	X Walk 1 Direction	To N		X Walk 2 Direction	N/A
N/A	X Walk 1 Width (in)	N/A	N/A	X Walk 2 Width (in)	N/A
	X Walk 1 Slope (%)	0.4		X Walk 2 Slope (%)	N/A
	X Walk 1 X Slope (%)	2.7		X Walk 2 X Slope (%)	N/A

N/A	Ramp inside XWalk1?	N/A	N/A	Ramp inside XWalk2?	N/A
	Road Slope (%)	N/A	N/A	Clear Space?	N/A
	Road X Slope (%)	N/A	N/A	Clear Space to XWalk (in)	N/A
N/A	Any Obstructions?	N/A	N/A	Storm Grate/Utility Hazard?	N/A
	Obstruction Type			Storm Grate/Utility Type	
		N/A			N/A
			Yes	Surface Condition? (G/P)	Good

Possible Solutions:

Remove & Replace Entire Ramp.

Total Cost: \$ 1850.00
