Access Compliance Report

Public Rights-of-Way

(Curb Ramps)

Intersection ID: N/A	Main Street: S_COLLEGE_ST	Cross Street: E_TRADE_ST	Location: NE
ADA ID: 0EB9712D003B	Ramp Type: BlendTrans1	Initial Pass/Fail: Fail	Overall Compliance: No
Severity Score: 8.75			
Codes/Mitigation Info/Possible Solution		Field Measurements/Component Compliance

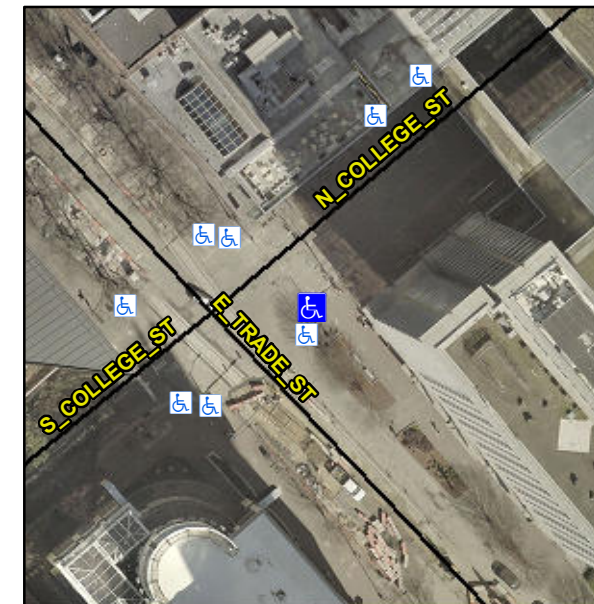
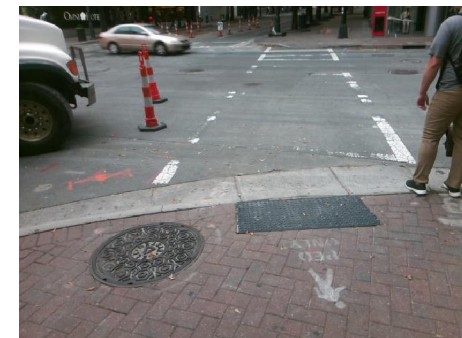
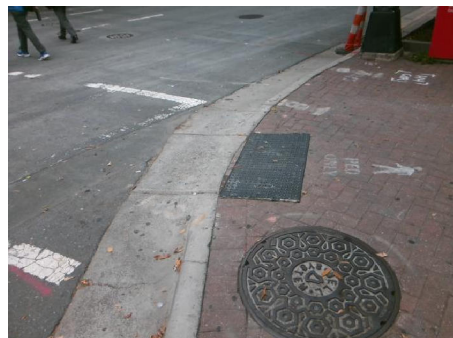
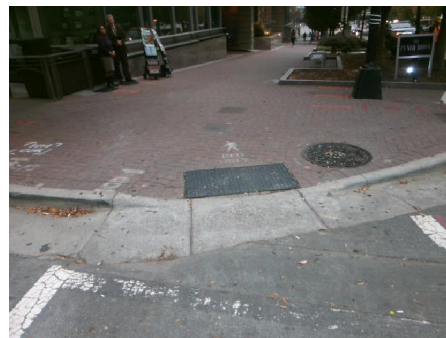
Not Found, R304.5.1

Compliance	Description	Data	Compliance	Description	Data
N/A	Ramp Length (in)	27.0	Yes	BlendTrans Slope (%)	4.5
No	Ramp Width (in)	43.0	Yes	BlendTrans XSlope (%)	0.3
N/A	Flare Type LT	N/A	N/A	Flare Type RT	N/A
N/A	Flare Slope LT (%)	N/A	N/A	Flare Slope RT (%)	N/A
N/A	Flare Traversable LT?	N/A	N/A	Flare Traversable RT?	N/A
N/A	Landing Length (in)	N/A	N/A	DWS Provided?	N/A
N/A	Landing Width (in)	N/A	N/A	DWS Contrast?	N/A
N/A	Landing Slope (%)	N/A	N/A	DWS Length (in)	N/A
N/A	Landing X Slope (%)	N/A	N/A	DWS Full Width?	N/A
N/A	Landing Curb? (Y/N)	N/A	N/A	DWS Offset (in)	N/A
N/A	Shared Landing?	N/A			
N/A	Gutter Ponding?	N/A	N/A	Gutter Slope (%)	N/A
N/A	Gutter Lip Ht (in)	N/A	N/A	Gutter X Slope (%)	N/A
N/A	Painted X Walk1?	Yes	N/A	Painted X Walk2?	N/A
	X Walk 1 Direction	To NW		X Walk 2 Direction	N/A
	X Walk 1 Width (in)	109.0		X Walk 2 Width (in)	N/A
	X Walk 1 Slope (%)	4.6		X Walk 2 Slope (%)	N/A
	X Walk 1 X Slope (%)	0.4		X Walk 2 X Slope (%)	N/A

N/A	Ramp inside XWalk1?	Yes	N/A	Ramp inside XWalk2?	N/A
	Road Slope (%)	0.4		Clear Space?	N/A
	Road X Slope (%)	4.6	N/A	Clear Space to XWalk (in)	N/A
N/A	Any Obstructions?	N/A	N/A	Storm Grate/Utility Hazard?	N/A
	Obstruction Type			Storm Grate/Utility Type	
		N/A			N/A
			Yes	Surface Condition? (G/P)	Good
			No	Curb Slope (%)	6.3

Possible Solutions:

Remove & Replace Curb Ramp With Two New Directional Ramps or Equivalent.
