Access Compliance Report

Public Rights-of-Way

(Curb Ramps)

Intersection ID: 10035551	Main Street: REA_RD	Cross Street: N/A	Location: SW
ADA ID: 0EBB0FAE299D	Ramp Type: PerpDiag	Initial Pass/Fail: Fail	Overall Compliance: No
Codes/Mitigation Info/Possible Solution		Field Measurements/Component Compliance	
Severity Score: 21.25

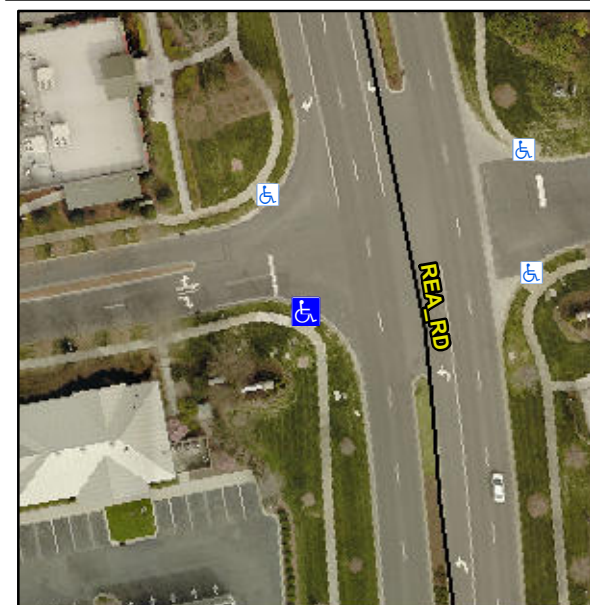
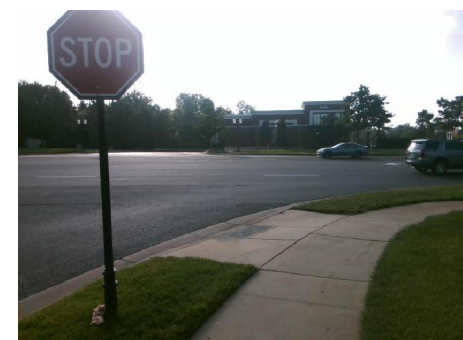
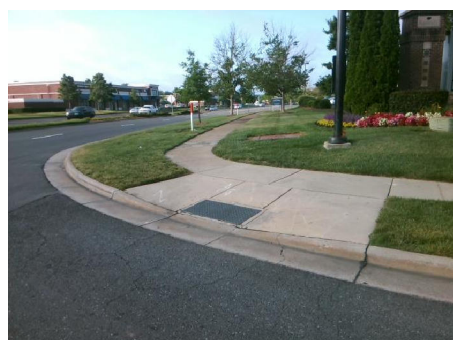
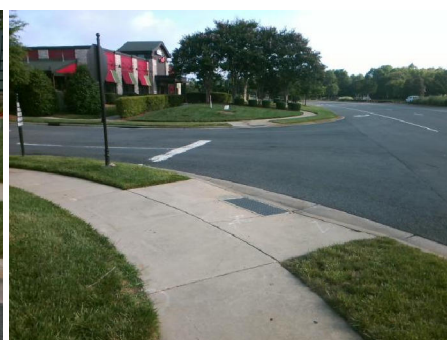
Not Found, R304.5.1, R304.2.2

Compliance	Description	Data	Compliance	Description	Data
N/A	Ramp Length (in)	73.0	No	Ramp Slope (%)	11.6
No	Ramp Width (in)	43.0	Yes	Ramp XSlope (%)	0.6
N/A	Flare Type LT	N/A	N/A	Flare Type RT	N/A
N/A	Flare Slope LT (%)	N/A	N/A	Flare Slope RT (%)	N/A
N/A	Flare Traversable LT?	N/A	N/A	Flare Traversable RT?	N/A
N/A	Landing Length (in)	N/A	N/A	DWS Provided?	N/A
N/A	Landing Width (in)	N/A	N/A	DWS Contrast?	N/A
N/A	Landing Slope (%)	N/A	N/A	DWS Length (in)	N/A
N/A	Landing X Slope (%)	N/A	N/A	DWS Full Width?	N/A
N/A	Landing Curb? (Y/N)	N/A	N/A	DWS Offset (in)	N/A
N/A	Shared Landing?	N/A			
N/A	Gutter Ponding?	N/A	N/A	Gutter Slope (%)	N/A
N/A	Gutter Lip Ht (in)	N/A	N/A	Gutter X Slope (%)	N/A
N/A	Painted X Walk1?	No	N/A	Painted X Walk2?	No
	X Walk 1 Direction	To E		X Walk 2 Direction	To N
N/A	X Walk 1 Width (in)	N/A	N/A	X Walk 2 Width (in)	N/A
	X Walk 1 Slope (%)	2.0		X Walk 2 Slope (%)	2.1
	X Walk 1 X Slope (%)	1.8		X Walk 2 X Slope (%)	3.0

N/A	Ramp inside XWalk1?	N/A	N/A	Ramp inside XWalk2?	N/A
	Road Slope (%)	1.3	N/A	Clear Space?	N/A
	Road X Slope (%)	1.7	N/A	Clear Space to XWalk (in)	N/A
N/A	Any Obstructions?	N/A	N/A	Storm Grate/Utility Hazard?	N/A
	Obstruction Type			Storm Grate/Utility Type	
		N/A			N/A
		Yes		Surface Condition? (G/P)	Good

Remove & Replace Curb Ramp With Two New Directional Ramps or Equivalent.

Total Cost: \$ 3200.00
