Access Compliance Report

Public Rights-of-Way

(Curb Ramps)

Intersection ID: N/A	Main Street: PERIMETER_PY	Cross Street: N/A	Location: NE
ADA ID: 0EBDD96EE6F6	Ramp Type: PerpDiag	Initial Pass/Fail: Fail	Overall Compliance: No
		Severity Score: 25

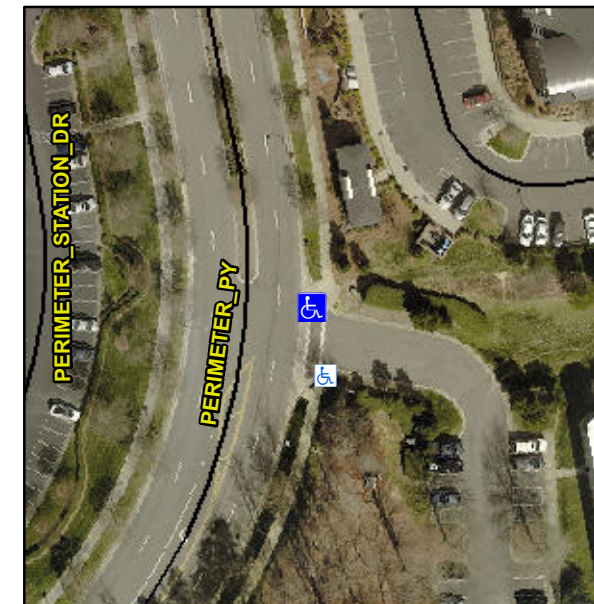
Compliance	Description	Data	Compliance	Description	Data
N/A	Ramp Length (in)	78.0	No	Ramp Slope (%)	10.4
Yes	Ramp Width (in)	48.0	No	Ramp XSlope (%)	6.3
N/A	Flare Type LT	N/A	N/A	Flare Type RT	N/A
N/A	Flare Slope LT (%)	N/A	N/A	Flare Slope RT (%)	N/A
N/A	Flare Traversable LT?	No	N/A	Flare Traversable RT?	No
N/A	Landing Length (in)	N/A	N/A	DWS Provided?	N/A
N/A	Landing Width (in)	N/A	N/A	DWS Contrast?	N/A
N/A	Landing Slope (%)	N/A	N/A	DWS Length (in)	N/A
N/A	Landing X Slope (%)	N/A	N/A	DWS Full Width?	N/A
N/A	Landing Curb? (Y/N)	N/A	N/A	DWS Offset (in)	N/A
N/A	Shared Landing?	N/A			
N/A	Gutter Ponding?	N/A	N/A	Gutter Slope (%)	N/A
N/A	Gutter Lip Ht (in)	N/A	N/A	Gutter X Slope (%)	N/A
N/A	Painted X Walk1?	No	N/A	Painted X Walk2?	Yes
	X Walk 1 Direction	To W		X Walk 2 Direction	To S
N/A	X Walk 1 Width (in)	N/A	N/A	X Walk 2 Width (in)	70.0
	X Walk 1 Slope (%)	7.0		X Walk 2 Slope (%)	0.1
	X Walk 1 X Slope (%)	0.1		X Walk 2 X Slope (%)	5.8

N/A	Ramp inside XWalk1?	N/A	N/A	Ramp inside XWalk2?	Yes
	Road Slope (%)	2.9	N/A	Clear Space?	N/A
	Road X Slope (%)	4.0	N/A	Clear Space to XWalk (in)	N/A
N/A	Any Obstructions?	N/A	N/A	Storm Grate/Utility Hazard?	N/A
	Obstruction Type			Storm Grate/Utility Type	
		N/A			N/A
		Yes		Surface Condition? (G/P)	Good

Remove & Replace Curb Ramp With Two New Directional Ramps or Equivalent.

R304.2.2, R304.5.3

Total Cost: \$ 3200.00
