Access Compliance Report

Public Rights-of-Way

(Curb Ramps)

Intersection ID: 49926	Main Street: CAMPBELL_HALL_CT	Cross Street: WOBURN_RD	Location: SW
ADA ID: 0ECF6B653A7A	Ramp Type: Perp	Initial Pass/Fail: Fail	Overall Compliance: No
Severity Score: 21.25			
Codes/Mitigation Info/Possible Solution		Field Measurements/Component Compliance

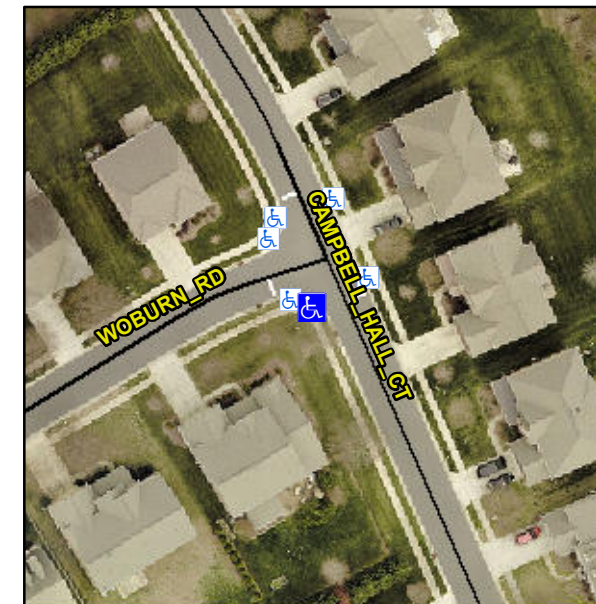
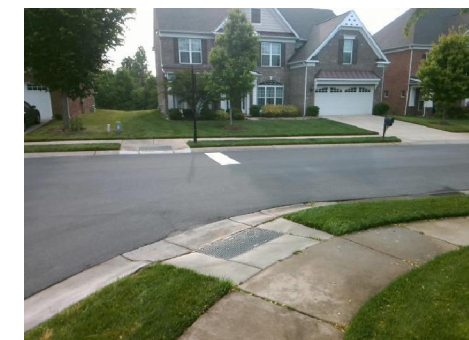
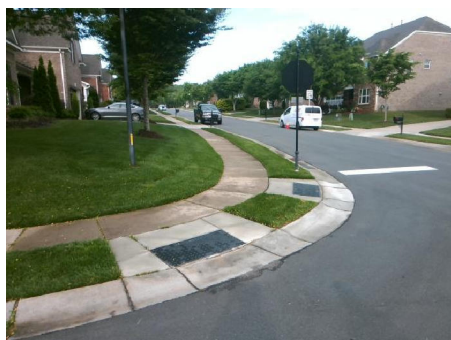
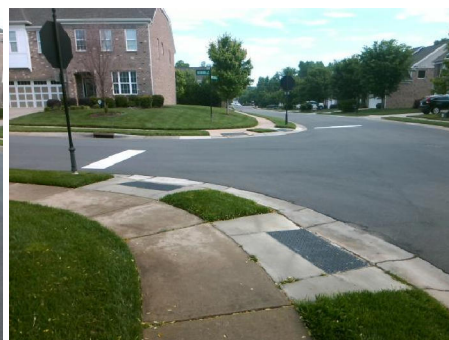
Not Found, R304.5.1, R304.2.2

Compliance	Description	Data	Compliance	Description	Data
N/A	Ramp Length (in)	46.0	No	Ramp Slope (%)	10.4
No	Ramp Width (in)	47.0	Yes	Ramp XSlope (%)	1.9
N/A	Flare Type LT	N/A	N/A	Flare Type RT	N/A
N/A	Flare Slope LT (%)	N/A	N/A	Flare Slope RT (%)	N/A
N/A	Flare Traversable LT?	N/A	N/A	Flare Traversable RT?	N/A
N/A	Landing Length (in)	N/A	N/A	DWS Provided?	N/A
N/A	Landing Width (in)	N/A	N/A	DWS Contrast?	N/A
N/A	Landing Slope (%)	N/A	N/A	DWS Length (in)	N/A
N/A	Landing X Slope (%)	N/A	N/A	DWS Full Width?	N/A
N/A	Landing Curb? (Y/N)	N/A	N/A	DWS Offset (in)	N/A
N/A	Shared Landing?	N/A			
N/A	Gutter Ponding?	N/A	N/A	Gutter Slope (%)	N/A
N/A	Gutter Lip Ht (in)	N/A	N/A	Gutter X Slope (%)	N/A
N/A	Painted X Walk1?	No	N/A	Painted X Walk2?	N/A
	X Walk 1 Direction	To NE		X Walk 2 Direction	N/A
N/A	X Walk 1 Width (in)	N/A	N/A	X Walk 2 Width (in)	N/A
	X Walk 1 Slope (%)	2.0		X Walk 2 Slope (%)	N/A
	X Walk 1 X Slope (%)	2.3		X Walk 2 X Slope (%)	N/A

N/A	Ramp inside XWalk1?	N/A	N/A	Ramp inside XWalk2?	N/A
	Road Slope (%)	N/A	N/A	Clear Space?	N/A
	Road X Slope (%)	N/A	N/A	Clear Space to XWalk (in)	N/A
N/A	Any Obstructions?	N/A	N/A	Storm Grate/Utility Hazard?	N/A
	Obstruction Type			Storm Grate/Utility Type	
		N/A			N/A
		Yes		Surface Condition? (G/P)	Good

Remove & Replace Entire Ramp.

Total Cost: \$ 1850.00
