## **Access Compliance Report Public Rights-of-Way** (Curb Ramps)

Intersection ID: 53401 Main Street: VAWTER\_DR **Cross Street: AGNEW\_DR** Location: NE **Severity Score: Overall Compliance: No** ADA ID: 0ED24F941CFF Ramp Type: Perp Initial Pass/Fail: Pass 2.75

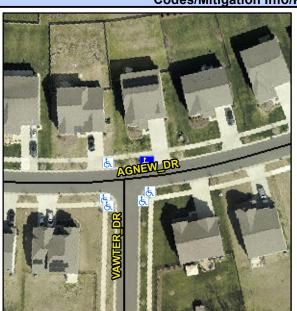
| Field Measurements/Component Compliance | | | | | | | |
|---|---|---|---|---|---|--|--|
| Yes | Ramp Width (in) | 48.0 | No | Ramp XSlope (%) | 3.3 | | |
| N/A | Flare Slope LT (%) | 5.1 | No | Flare Slope RT (%) | 11.6 | | |
| N/A | Landing Curb? (Y/N) | No | No | DWS Offset (in) | 5.0 | | |

| /Possible Solution | |
|---|---|
| Remove & Replace Entire Ramp. | N/A |
| R304.5.3, R304.2.3, R305.2 | Yes |

1850.00
