Access Compliance Report

Public Rights-of-Way

(Curb Ramps)

Intersection ID: 44453	Main Street: BAYVIEW_PY	Cross Street: RUMNEY_CT	Location: NW
ADA ID: 0ED4616FBC32	Ramp Type: BlendTrans1	Initial Pass/Fail: Fail	Overall Compliance: No
Codes/Mitigation Info/Possible Solution		Field Measurements/Component Compliance	
Severity Score: 8.75

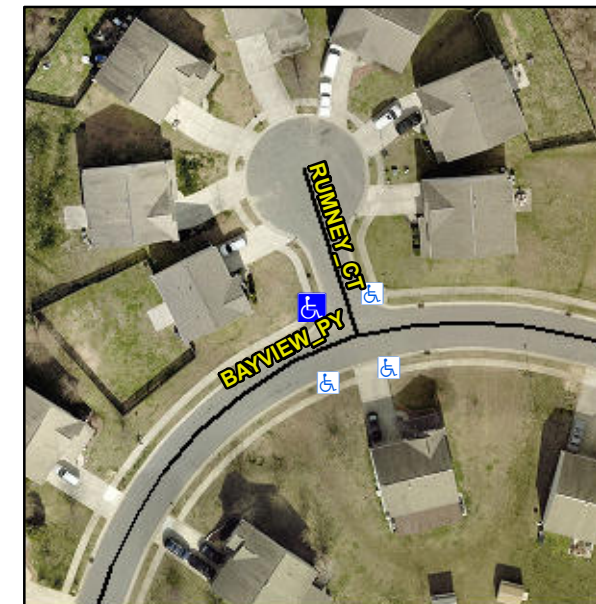
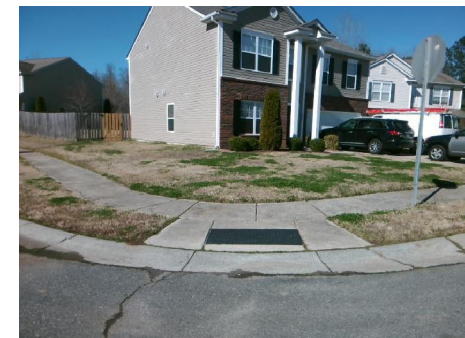
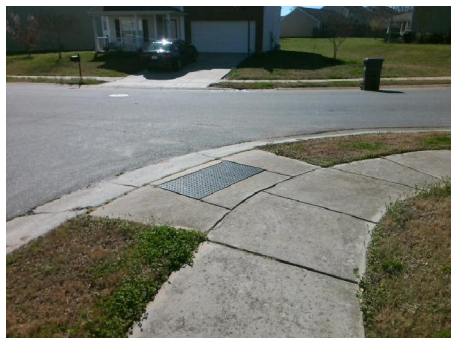
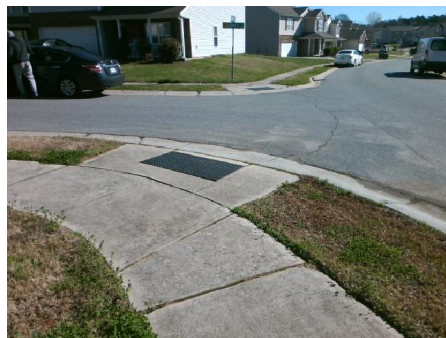
Not Found, R304.5.1

Compliance	Description	Data	Compliance	Description	Data
N/A	Ramp Length (in)	49.5	Yes	BlendTrans Slope (%)	2.6
No	Ramp Width (in)	47.5	Yes	BlendTrans XSlope (%)	1.7
N/A	Flare Type LT	N/A	N/A	Flare Type RT	N/A
N/A	Flare Slope LT (%)	N/A	N/A	Flare Slope RT (%)	N/A
N/A	Flare Traversable LT?	N/A	N/A	Flare Traversable RT?	N/A
N/A	Landing Length (in)	N/A	N/A	DWS Provided?	N/A
N/A	Landing Width (in)	N/A	N/A	DWS Contrast?	N/A
N/A	Landing Slope (%)	N/A	N/A	DWS Length (in)	N/A
N/A	Landing X Slope (%)	N/A	N/A	DWS Full Width?	N/A
N/A	Landing Curb? (Y/N)	N/A	N/A	DWS Offset (in)	N/A
N/A	Shared Landing?	N/A			
N/A	Gutter Ponding?	N/A	N/A	Gutter Slope (%)	N/A
N/A	Gutter Lip Ht (in)	N/A	N/A	Gutter X Slope (%)	N/A
N/A	Painted X Walk1?	No	N/A	Painted X Walk2?	No
	X Walk 1 Direction	To S		X Walk 2 Direction	To E
	X Walk 1 Width (in)	N/A		X Walk 2 Width (in)	N/A
	X Walk 1 Slope (%)	0.6		X Walk 2 Slope (%)	0.7
	X Walk 1 X Slope (%)	0.2		X Walk 2 X Slope (%)	1.4

N/A	Ramp inside XWalk1?	N/A	N/A	Ramp inside XWalk2?	N/A
	Road Slope (%)	0.8		Clear Space?	N/A
	Road X Slope (%)	0.6	N/A	Clear Space to XWalk (in)	N/A
N/A	Any Obstructions?	N/A	N/A	Storm Grate/Utility Hazard?	N/A
	Obstruction Type			Storm Grate/Utility Type	
		N/A			N/A
			Yes	Surface Condition? (G/P)	Good
			No	Curb Slope (%)	8.0

Remove & Replace Curb Ramp With Two New Directional Ramps or Equivalent.
