# Access Compliance Report

## Public Rights-of-Way

### (Curb Ramps)

Intersection ID: 11882	Main Street: N_PINE_ST	Cross Street: W_5TH_ST	Location:	N
ADA ID: 0ED5239B0FA5	Ramp Type: Perp	Initial Pass/Fail: Pass	Overall Compliance: No	Severity Score: 5
Codes/Mitigation Info/Possible Solution		Field Measurements/Component Compliance

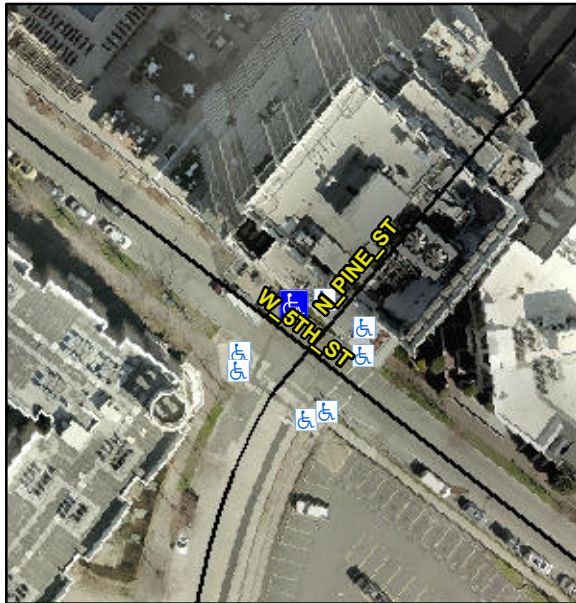
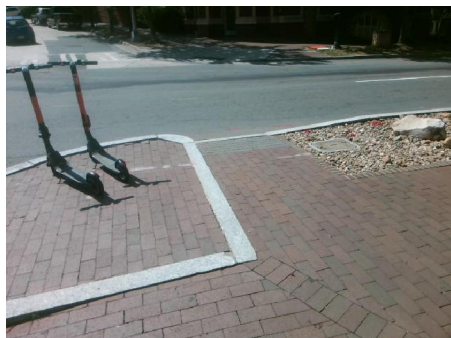
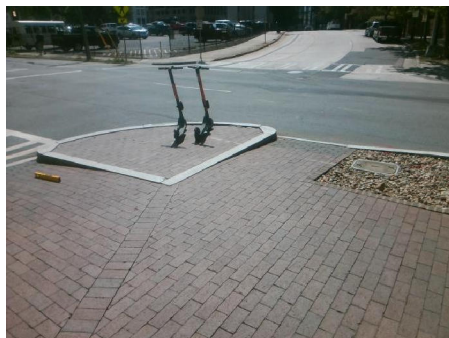
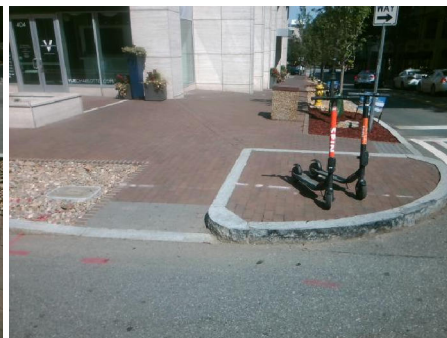
**Not Found, R304.2.2-Perp, R304.3.2-Para, R304.2.3**

Compliance	Description	Data	Compliance	Description	Data
N/A	Ramp Length (in)	73.0	Yes	Ramp Slope (%)	5.9
Yes	Ramp Width (in)	49.0	Yes	Ramp XSlope (%)	0.4
Yes	Flare Type L	Curbed_NoWalkSurface	No	Flare Type RT	N/A
Yes	Flare Slope LT (%)	N/A	N/A	Flare Slope RT (%)	N/A
N/A	Flare Traversable LT?	No	N/A	Flare Traversable RT?	No
Yes	Landing Length (in)	60.0	Yes	DWS Provided?	Yes
Yes	Landing Width (in)	49.0	Yes	DWS Contrast?	Yes
No	Landing Slope (%)	2.2	Yes	DWS Length (in)	24.0
Yes	Landing X Slope (%)	0.5	Yes	DWS Full Width?	Yes
N/A	Landing Curb? (Y/N)	No	Yes	DWS Offset (in)	0.0
N/A	Shared Landing?	Yes			
Yes	Gutter Ponding?	No	Yes	Gutter Slope (%)	2.2
Yes	Gutter Lip Ht (in)	0.0	Yes	Gutter X Slope (%)	2.0
N/A	Painted X Walk1?	No	N/A	Painted X Walk2?	N/A
	X Walk 1 Direction	To SW		X Walk 2 Direction	N/A
N/A	X Walk 1 Width (in)	N/A	N/A	X Walk 2 Width (in)	N/A
	X Walk 1 Slope (%)	2.5		X Walk 2 Slope (%)	N/A
	X Walk 1 X Slope (%)	2.5		X Walk 2 X Slope (%)	N/A

N/A	Ramp inside XWalk1?	N/A	N/A	Ramp inside XWalk2?	N/A
	Road Slope (%)	N/A	N/A	Clear Space?	Yes
	Road X Slope (%)	N/A	N/A	Clear Space to XWalk (in)	N/A
Yes	Any Obstructions?	No	Yes	Storm Grate/Utility Hazard?	No
	Obstruction Type			Storm Grate/Utility Type	
		N/A			N/A
			Yes	Surface Condition? (G/P)	Good

**Remove & Replace Entire Ramp.**
