# Access Compliance Report

## Public Rights-of-Way

### (Curb Ramps)

Intersection ID: 52627	Main Street: PICASSO TERRACE LN	Cross Street: CORMWELL LN	Location: NE
ADA ID: 0EE476CC621B	Ramp Type: Perp	Initial Pass/Fail: Fail	Overall Compliance: No
		Severity Score: 12.5

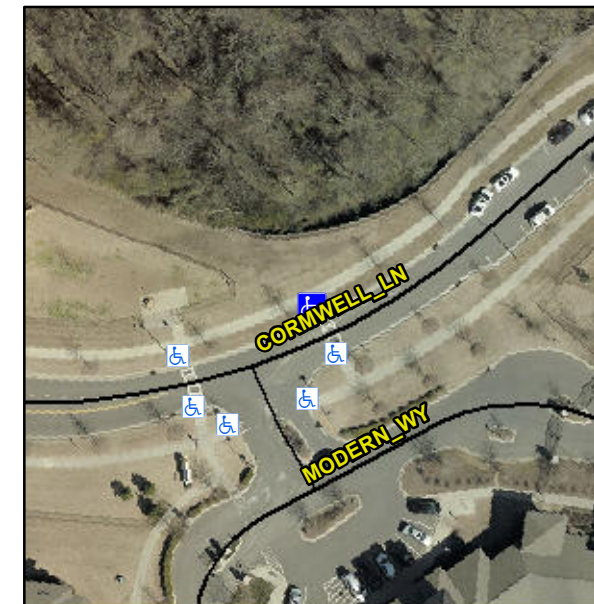
**Not Found, R304.2.2**

Compliance	Description	Data	Compliance	Description	Data
N/A	Ramp Length (in)	96.0	No	Ramp Slope (%)	9.5
Yes	Ramp Width (in)	59.0	Yes	Ramp XSlope (%)	0.3
N/A	Flare Type LT	N/A	N/A	Flare Type RT	N/A
N/A	Flare Slope LT (%)	N/A	N/A	Flare Slope RT (%)	N/A
N/A	Flare Traversable LT?	N/A	N/A	Flare Traversable RT?	N/A
N/A	Landing Length (in)	N/A	N/A	DWS Provided?	N/A
N/A	Landing Width (in)	N/A	N/A	DWS Contrast?	N/A
N/A	Landing Slope (%)	N/A	N/A	DWS Length (in)	N/A
N/A	Landing X Slope (%)	N/A	N/A	DWS Full Width?	N/A
N/A	Landing Curb? (Y/N)	N/A	N/A	DWS Offset (in)	N/A
N/A	Shared Landing?	N/A			
N/A	Gutter Ponding?	N/A	N/A	Gutter Slope (%)	N/A
N/A	Gutter Lip Ht (in)	N/A	N/A	Gutter X Slope (%)	N/A
N/A	Painted X Walk1?	Yes	N/A	Painted X Walk2?	N/A
	X Walk 1 Direction	To S		X Walk 2 Direction	N/A
N/A	X Walk 1 Width (in)	63.0	N/A	X Walk 2 Width (in)	N/A
	X Walk 1 Slope (%)	2.6		X Walk 2 Slope (%)	N/A
	X Walk 1 X Slope (%)	5.1		X Walk 2 X Slope (%)	N/A

**Remove & Replace Entire Ramp.**
