Access Compliance Report

Public Rights-of-Way

(Curb Ramps)

Intersection ID: 15822	Main Street: CHIPPENDALE_RD	Cross Street: TULANE_ST	Location: NW
ADA ID: 0EEE0AE0A0FA	Ramp Type: Para	Initial Pass/Fail: Fail	Overall Compliance: No
			Severity Score: 26.25

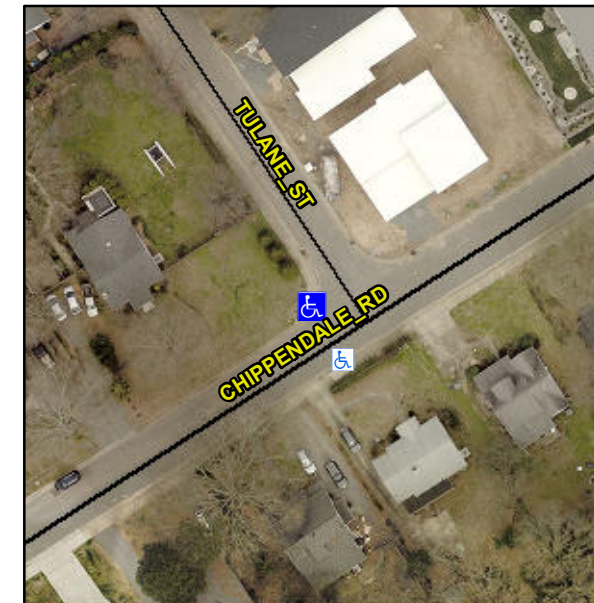
RT RP < 5%

R304.3.2, R304.5.3

Compliance	Description	Data	Compliance	Description	Data
N/A	Ramp Length LT (in)	64.0	N/A	Ramp Length RT (in)	65.5
Yes	Ramp Width LT (in)	59.0	Yes	Ramp Width RT (in)	58.5
No	Ramp Slope LT (%)	12.9	Yes	Ramp Slope RT (%)	0.7
No	Ramp XSlope LT (%)	3.8	Yes	Ramp XSlope RT (%)	0.7
N/A	Landing Length (in)	N/A	N/A	DWS Provided?	N/A
N/A	Landing Width (in)	N/A	N/A	DWS Contrast?	N/A
N/A	Landing Slope (%)	N/A	N/A	DWS Length (in)	N/A
N/A	Landing X Slope (%)	N/A	N/A	DWS Full Width?	N/A
N/A	Landing Curb? (Y/N)	N/A	N/A	DWS Offset (in)	N/A
N/A	Shared Landing?	N/A			
N/A	Gutter Ponding?	N/A	N/A	Gutter Slope (%)	N/A
N/A	Gutter Lip Ht (in)	N/A	N/A	Gutter X Slope (%)	N/A
N/A	Painted X Walk1?	No	N/A	Painted X Walk2?	N/A
	X Walk 1 Direction	To S		X Walk 2 Direction	N/A
N/A	X Walk 1 Width (in)	N/A	N/A	X Walk 2 Width (in)	N/A
	X Walk 1 Slope (%)	0.6		X Walk 2 Slope (%)	N/A
	X Walk 1 X Slope (%)	1.9		X Walk 2 X Slope (%)	N/A
N/A	Ramp inside XWalk1?	N/A	N/A	Ramp inside XWalk2?	N/A

Road Slope (%)	N/A	N/A	Clear Space?	N/A
	Road X Slope (%)	N/A	N/A	Clear Space to XWalk (in)	N/A
N/A	Any Obstructions?	N/A	N/A	Storm Grate/Utility Hazard?	N/A
	Obstruction Type			Storm Grate/Utility Type	
		N/A			N/A
			Yes	Surface Condition? (G/P)	Good
			N/A	Curb Slope (%)	3.4

Remove & Replace Entire Ramp.
