# Access Compliance Report

## Public Rights-of-Way

| Intersection ID: 50240 | Main Street: LONGSTONE_LN | Cross Street: CEDAR_WALK_LN | Location: W |
| ADA ID: 0EF712CBA343 | Ramp Type: BlendTrans1 | Initial Pass/Fail: Pass | Overall Compliance: No |

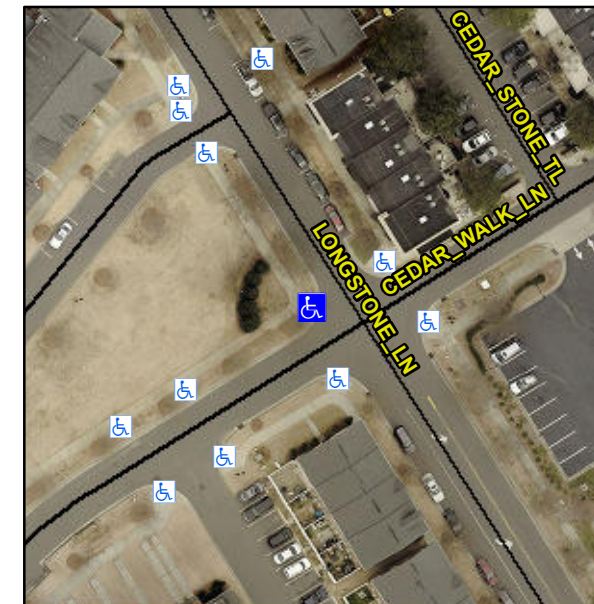
**R304.5.3**

| Compliance | Description | Data | Compliance | Description | Data |
|---|---|---|---|---|---|
| Yes | Gutter Lip Ht (in) | 0.0 | No | Gutter X Slope (%) | 3.9 |

Possible Solutions:

**Remove & Replace Gutter.**

Total Cost: \$ 750.00
