Access Compliance Report

Public Rights-of-Way

(Curb Ramps)

Intersection ID: 10020377	Main Street: BALLANTYNE CORPORATE PL	Cross Street: N/A	Location: SW
ADA ID: 0EF962D257BA	Ramp Type: Perp	Initial Pass/Fail: Fail	Overall Compliance: No
Severity Score: 21.25			
Codes/Mitigation Info/Possible Solution		Field Measurements/Component Compliance

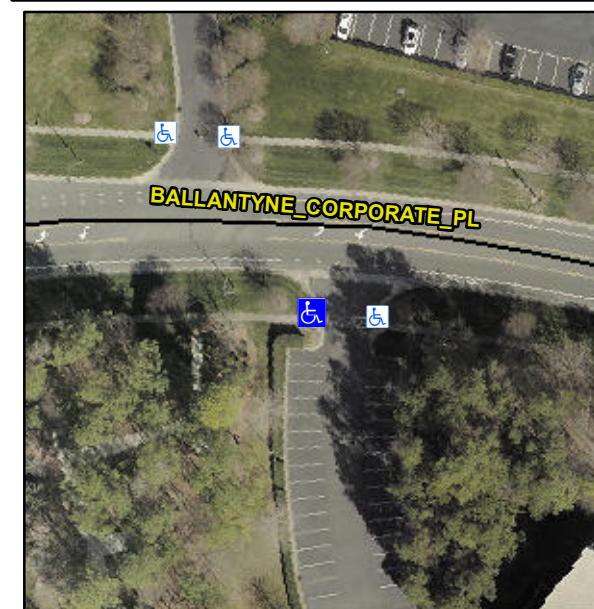
Compliance	Description	Data	Compliance	Description	Data
N/A	Ramp Length (in)	75.0	No	Ramp Slope (%)	8.7
No	Ramp Width (in)	46.5	Yes	Ramp XSlope (%)	0.6
N/A	Flare Type LT	N/A	N/A	Flare Type RT	N/A
N/A	Flare Slope LT (%)	N/A	N/A	Flare Slope RT (%)	N/A
N/A	Flare Traversable LT?	N/A	N/A	Flare Traversable RT?	N/A
N/A	Landing Length (in)	N/A	N/A	DWS Provided?	N/A
N/A	Landing Width (in)	N/A	N/A	DWS Contrast?	N/A
N/A	Landing Slope (%)	N/A	N/A	DWS Length (in)	N/A
N/A	Landing X Slope (%)	N/A	N/A	DWS Full Width?	N/A
N/A	Landing Curb? (Y/N)	N/A	N/A	DWS Offset (in)	N/A
N/A	Shared Landing?	N/A			
N/A	Gutter Ponding?	N/A	N/A	Gutter Slope (%)	N/A
N/A	Gutter Lip Ht (in)	N/A	N/A	Gutter X Slope (%)	N/A
N/A	Painted X Walk1?	No	N/A	Painted X Walk2?	N/A
	X Walk 1 Direction	To E		X Walk 2 Direction	N/A
N/A	X Walk 1 Width (in)	N/A	N/A	X Walk 2 Width (in)	N/A
	X Walk 1 Slope (%)	3.2		X Walk 2 Slope (%)	N/A
	X Walk 1 X Slope (%)	2.7		X Walk 2 X Slope (%)	N/A

N/A	Ramp inside XWalk1?	N/A	N/A	Ramp inside XWalk2?	N/A
	Road Slope (%)	N/A	N/A	Clear Space?	N/A
	Road X Slope (%)	N/A	N/A	Clear Space to XWalk (in)	N/A
N/A	Any Obstructions?	N/A	N/A	Storm Grate/Utility Hazard?	N/A
	Obstruction Type			Storm Grate/Utility Type	
		N/A			N/A
		Yes		Surface Condition? (G/P)	Good

Possible Solutions:

Remove & Replace Entire Ramp.

R304.5.1, R304.2.2

Total Cost: \$ 1850.00
