# Access Compliance Report

## Public Rights-of-Way

### (Curb Ramps)

Intersection ID: 20476	Main Street: SHADOWCREST_DR	Cross Street: WOODKNOLL_DR	Location: W
ADA ID: 0EFA08E440B6	Ramp Type: Perp	Initial Pass/Fail: Fail	Overall Compliance: No
Codes/Mitigation Info/Possible Solution		Field Measurements/Component Compliance	
Severity Score: 48.75

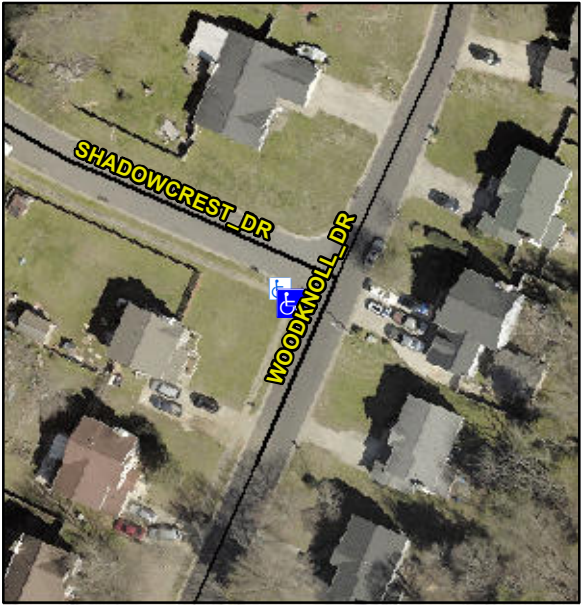
Possible Solutions:	Compliance	Description	Data	Compliance	Description	Data
	Remove & Replace Entire Ramp.	N/A	Ramp Length (in)	91.0	No	Ramp Slope (%)	9.8
		No	Ramp Width (in)	25.0	No	Ramp XSlope (%)	4.0
		N/A	Flare Type LT	N/A	N/A	Flare Type RT	N/A
		N/A	Flare Slope LT (%)	N/A	N/A	Flare Slope RT (%)	N/A
		N/A	Flare Traversable LT?	N/A	N/A	Flare Traversable RT?	N/A
		N/A	Landing Length (in)	N/A	N/A	DWS Provided?	N/A
		N/A	Landing Width (in)	N/A	N/A	DWS Contrast?	N/A
		N/A	Landing Slope (%)	N/A	N/A	DWS Length (in)	N/A
		N/A	Landing X Slope (%)	N/A	N/A	DWS Full Width?	N/A
<p>Surveyor Notes:</p> <p>N/A</p> <p>PROW/ADA:</p> <p>R304.5.1, R304.2.2, R304.5.3</p>		N/A	Landing Curb? (Y/N)	N/A	N/A	DWS Offset (in)	N/A
		N/A	Shared Landing?	N/A			
		N/A	Gutter Ponding?	N/A	N/A	Gutter Slope (%)	N/A
		N/A	Gutter Lip Ht (in)	N/A	N/A	Gutter X Slope (%)	N/A
		N/A	Painted X Walk1?	No	N/A	Painted X Walk2?	N/A
			X Walk 1 Direction	To SE		X Walk 2 Direction	N/A

N/A	X Walk 1 Width (in)	N/A	N/A	X Walk 2 Width (in)	N/A
			X Walk 1 Slope (%)	3.1		X Walk 2 Slope (%)	N/A
			X Walk 1 X Slope (%)	1.0		X Walk 2 X Slope (%)	N/A
		N/A	Ramp inside XWalk1?	N/A	N/A	Ramp inside XWalk2?	N/A
<p>Street 1 Name</p> <p>Stop Condition-Street 2</p> <p>Street 2 Name</p> <p>Stop Condition-Street 1</p>			Road Slope (%)	N/A	N/A	Clear Space?	N/A
			Road X Slope (%)	N/A	N/A	Clear Space to XWalk (in)	N/A
		N/A	Any Obstructions?	N/A	N/A	Storm Grate/Utility Hazard?	N/A
			Obstruction Type			Storm Grate/Utility Type	
					N/A		N/A
					Yes	Surface Condition? (G/P)	Good
Total Cost:		\$	1850.00
