Access Compliance Report

Public Rights-of-Way

(Curb Ramps)

Intersection ID: 3029	Main Street: AMBER_GLEN_DR	Cross Street: GARNET_FIELD_CT	Location: NE
ADA ID: 0EFB0C5241D3	Ramp Type: Perp	Initial Pass/Fail: Fail	Overall Compliance: No
		Severity Score: 10

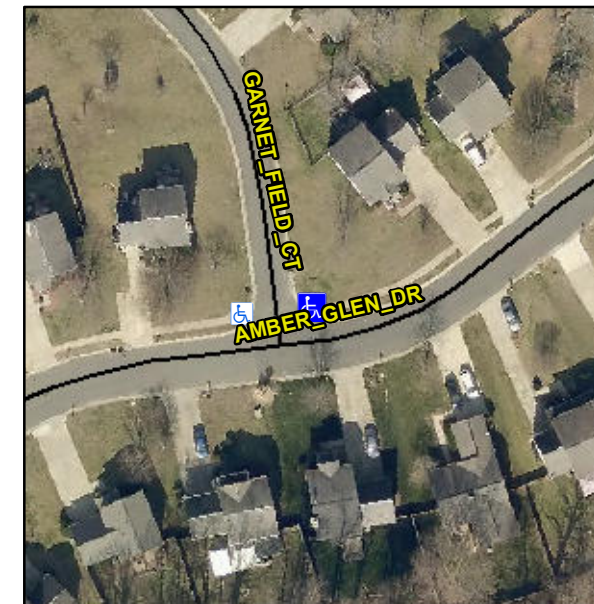
Not Found, R304.5.1, R304.5.3

Compliance	Description	Data	Compliance	Description	Data
N/A	Ramp Length (in)	48.0	Yes	Ramp Slope (%)	7.2
No	Ramp Width (in)	46.0	No	Ramp XSlope (%)	3.3
N/A	Flare Type LT	N/A	N/A	Flare Type RT	N/A
N/A	Flare Slope LT (%)	N/A	N/A	Flare Slope RT (%)	N/A
N/A	Flare Traversable LT?	N/A	N/A	Flare Traversable RT?	N/A
N/A	Landing Length (in)	N/A	N/A	DWS Provided?	N/A
N/A	Landing Width (in)	N/A	N/A	DWS Contrast?	N/A
N/A	Landing Slope (%)	N/A	N/A	DWS Length (in)	N/A
N/A	Landing X Slope (%)	N/A	N/A	DWS Full Width?	N/A
N/A	Landing Curb? (Y/N)	N/A	N/A	DWS Offset (in)	N/A
N/A	Shared Landing?	N/A			
N/A	Gutter Ponding?	N/A	N/A	Gutter Slope (%)	N/A
N/A	Gutter Lip Ht (in)	N/A	N/A	Gutter X Slope (%)	N/A
N/A	Painted X Walk1?	No	N/A	Painted X Walk2?	N/A
	X Walk 1 Direction	To W		X Walk 2 Direction	N/A
N/A	X Walk 1 Width (in)	N/A	N/A	X Walk 2 Width (in)	N/A
	X Walk 1 Slope (%)	2.7		X Walk 2 Slope (%)	N/A
	X Walk 1 X Slope (%)	1.9		X Walk 2 X Slope (%)	N/A

N/A	Ramp inside XWalk1?	N/A	N/A	Ramp inside XWalk2?	N/A
	Road Slope (%)	N/A	N/A	Clear Space?	N/A
	Road X Slope (%)	N/A	N/A	Clear Space to XWalk (in)	N/A
N/A	Any Obstructions?	N/A	N/A	Storm Grate/Utility Hazard?	N/A
	Obstruction Type			Storm Grate/Utility Type	
		N/A			N/A
			Yes	Surface Condition? (G/P)	Good

Remove & Replace Entire Ramp.
