# Access Compliance Report

## Public Rights-of-Way

### (Curb Ramps)

Intersection ID: 14661	Main Street: E_TREMONT_AV	Cross Street: WINTHROP_AV	Location:	E
ADA ID: 0F0C0F35B1A8	Ramp Type: Directional1	Initial Pass/Fail: Fail	Overall Compliance: No	Severity Score: 37.5
Codes/Mitigation Info/Possible Solution		Field Measurements/Component Compliance

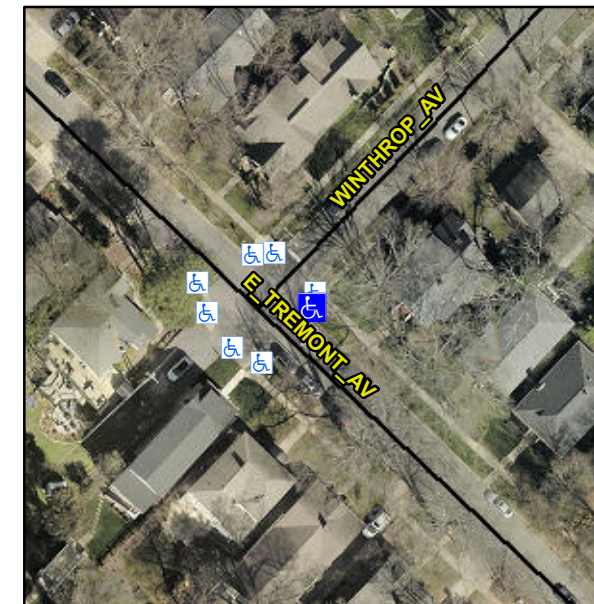
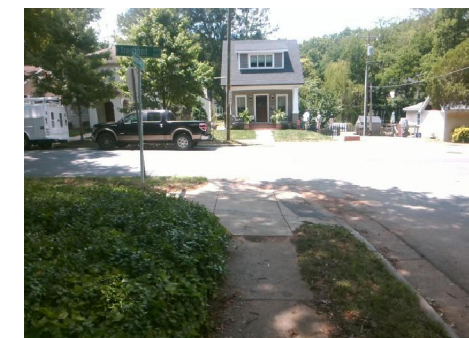
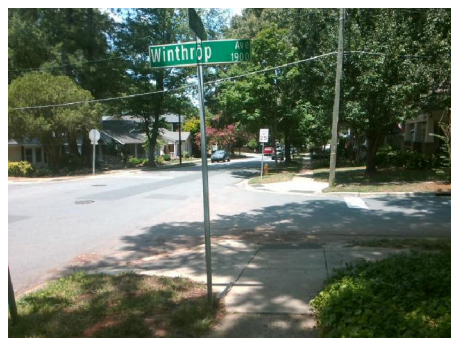
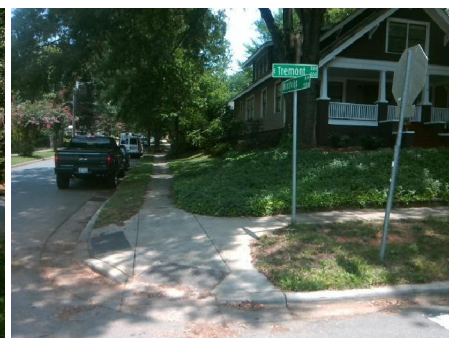
Compliance	Description	Data	Compliance	Description	Data
N/A	Ramp Length (in)	159.0	N/A	Grade Break?	N/A
Yes	Ramp Width (in)	48.5	N/A	Grade Break Slope (%)	0.0
No	Ramp Slope (%)	9.3	N/A	Grade Break XSlope (%)	0.0
No	Ramp XSlope (%)	7.9			
N/A	Flare Type LT	N/A	N/A	Flare Type RT	N/A
N/A	Flare Slope LT (%)	N/A	N/A	Flare Slope RT (%)	0.0
N/A	Flare Traversable LT?	N/A	N/A	Flare Traversable RT?	N/A
N/A	Landing Length (in)	0.0	N/A	DWS Provided?	N/A
N/A	Landing Width (in)	0.0	N/A	DWS Contrast?	N/A
N/A	Landing Slope (%)	0.0	N/A	DWS Length (in)	N/A
N/A	Landing X Slope (%)	0.0	N/A	DWS Full Width?	N/A
N/A	Landing Curb? (Y/N)	N/A	N/A	DWS Offset LT (in)	N/A
N/A	Shared Landing?	N/A	N/A	DWS Offset RT (in)	N/A
N/A	Gutter Ponding?	Yes	N/A	Gutter Slope (%)	N/A
N/A	Gutter Lip Ht (in)	0.0	N/A	Gutter X Slope (%)	N/A
N/A	Painted X Walk1?	No		Road Slope (%)	6.4
	X Walk 1 Direction	To SW		Road X Slope (%)	2.3
	X Walk 1 Width (in)	N/A		Clear Space?	N/A

X Walk 1 Slope (%)	6.4	N/A	Clear Space to XWalk (in)	N/A
	X Walk 1 X Slope (%)	2.3	N/A	Storm Grate/Utility Hazard?	N/A
N/A	Ramp inside XWalk1?	N/A		Storm Grate/Utility Type	
N/A	Any Obstructions?	N/A			N/A
	Obstruction Type		Yes	Surface Condition? (G/P)	Good
			N/A	Curb Slope (%)	1.6

**Remove & Replace Entire Ramp.**

**R304.2.2, R304.5.3**

\$ 1600.00
