# Access Compliance Report

## Public Rights-of-Way

### (Curb Ramps)

Intersection ID: 11787	Main Street: CAMP_GREENE_ST	Cross Street: HERBERT_SPAUGH_LN	Location: SW
ADA ID: 0F152614A1BE	Ramp Type: Perp	Initial Pass/Fail: Fail	Overall Compliance: No
Severity Score: 26.25			
Codes/Mitigation Info/Possible Solution		Field Measurements/Component Compliance

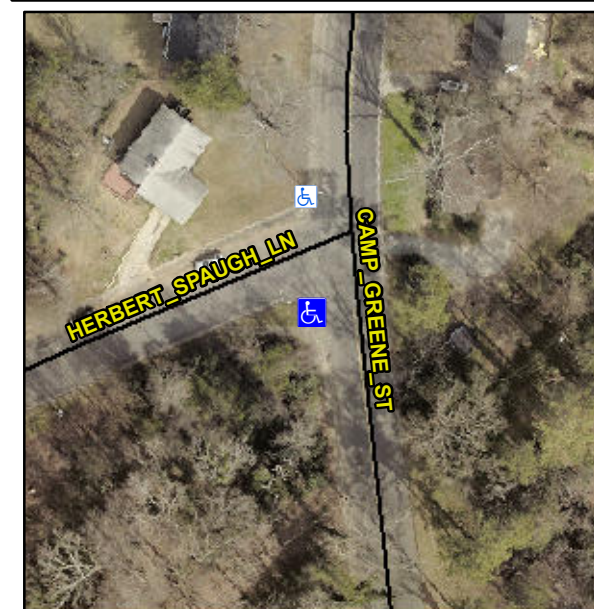
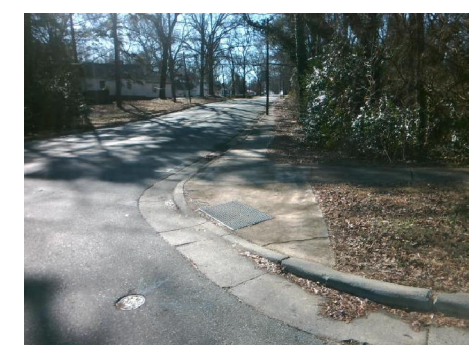
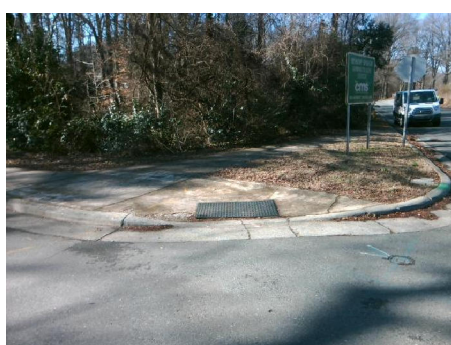
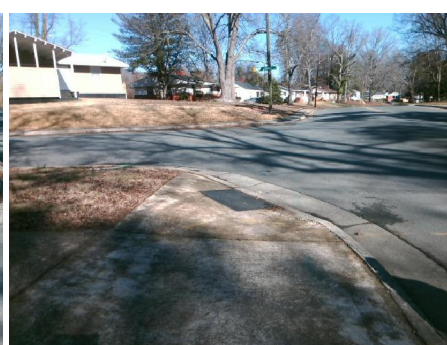
**Not Found, R304.2.2, R304.5.3**

Compliance	Description	Data	Compliance	Description	Data
N/A	Ramp Length (in)	56.0	No	Ramp Slope (%)	13.9
Yes	Ramp Width (in)	48.0	No	Ramp XSlope (%)	4.1
N/A	Flare Type LT	N/A	N/A	Flare Type RT	N/A
N/A	Flare Slope LT (%)	N/A	N/A	Flare Slope RT (%)	N/A
N/A	Flare Traversable LT?	N/A	N/A	Flare Traversable RT?	N/A
N/A	Landing Length (in)	N/A	N/A	DWS Provided?	N/A
N/A	Landing Width (in)	N/A	N/A	DWS Contrast?	N/A
N/A	Landing Slope (%)	N/A	N/A	DWS Length (in)	N/A
N/A	Landing X Slope (%)	N/A	N/A	DWS Full Width?	N/A
N/A	Landing Curb? (Y/N)	N/A	N/A	DWS Offset (in)	N/A
N/A	Shared Landing?	N/A			
N/A	Gutter Ponding?	N/A	N/A	Gutter Slope (%)	N/A
N/A	Gutter Lip Ht (in)	N/A	N/A	Gutter X Slope (%)	N/A
N/A	Painted X Walk1?	No	N/A	Painted X Walk2?	N/A
	X Walk 1 Direction	To N		X Walk 2 Direction	N/A
N/A	X Walk 1 Width (in)	N/A	N/A	X Walk 2 Width (in)	N/A
	X Walk 1 Slope (%)	0.5		X Walk 2 Slope (%)	N/A
	X Walk 1 X Slope (%)	0.3		X Walk 2 X Slope (%)	N/A

N/A	Ramp inside XWalk1?	N/A	N/A	Ramp inside XWalk2?	N/A
	Road Slope (%)	N/A	N/A	Clear Space?	N/A
	Road X Slope (%)	N/A	N/A	Clear Space to XWalk (in)	N/A
N/A	Any Obstructions?	N/A	N/A	Storm Grate/Utility Hazard?	N/A
	Obstruction Type			Storm Grate/Utility Type	
		N/A			N/A
		Yes		Surface Condition? (G/P)	Good

**Remove & Replace Entire Ramp.**
