Access Compliance Report

Public Rights-of-Way

(Curb Ramps)

Intersection ID: 5778	Main Street: JOHN_KIRK_DR	Cross Street: MARGIE_ANN_DR	Location: S
ADA ID: 0F1591C18F1A	Ramp Type: Perp	Initial Pass/Fail: Fail	Overall Compliance: No
			Severity Score: 13.75

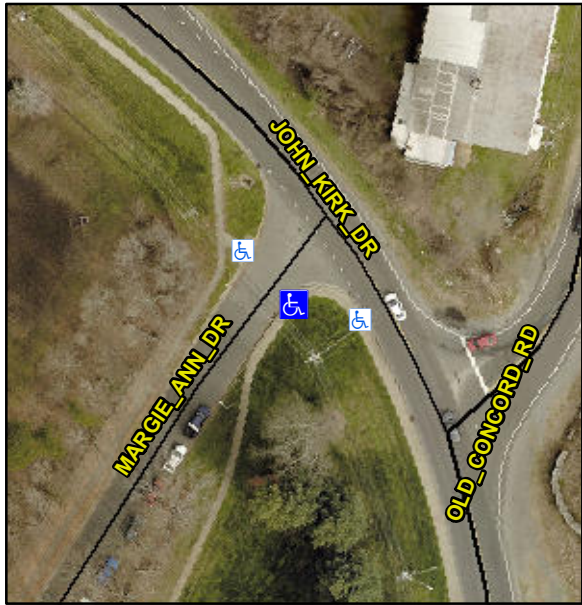
Possible Solutions:		Compliance	Description	Data
	Remove & Replace Entire Ramp.		N/A	Ramp Length (in)	50.0
			Yes	Ramp Width (in)	48.0
			N/A	Flare Type LT	N/A
			N/A	Flare Slope LT (%)	N/A
			N/A	Flare Traversable LT?	N/A
			N/A	Landing Length (in)	N/A
			N/A	Landing Width (in)	N/A
			N/A	Landing Slope (%)	N/A
			N/A	Landing X Slope (%)	N/A
<p>Surveyor Notes:</p> <p>N/A</p> <p>PROW/ADA:</p> <p>R304.2.2, R304.5.3</p>			N/A	Flare Type RT	N/A
			N/A	Flare Slope RT (%)	N/A
			N/A	Flare Traversable RT?	N/A
			N/A	DWS Provided?	N/A
			N/A	DWS Contrast?	N/A
			N/A	DWS Length (in)	N/A
			N/A	DWS Full Width?	N/A
			N/A	DWS Offset (in)	N/A
			N/A	Shared Landing?	N/A
			N/A	Gutter Ponding?	N/A
		N/A	Gutter Lip Ht (in)	N/A	
		N/A	Painted X Walk1?	No	
			X Walk 1 Direction	To NW	
		N/A	X Walk 1 Width (in)	N/A	
			X Walk 1 Slope (%)	3.3	
			X Walk 1 X Slope (%)	2.3

N/A	Ramp inside XWalk1?	N/A	
			Road Slope (%)	N/A	
			Road X Slope (%)	N/A	
		N/A	Any Obstructions?	N/A	
			Obstruction Type		
				N/A	N/A
				Yes	Surface Condition? (G/P) Good
Street 1 Name		MARGIE ANN DR			
Stop Condition-Street 2		None			
Street 2 Name		N/A			
Stop Condition-Street 1		N/A			
Total Cost:		\$ 1850.00
