# Access Compliance Report

## Public Rights-of-Way

### (Curb Ramps)

Intersection ID: N/A	Main Street: BACK_CREEK_DR	Cross Street: W_T_HARRIS_BV	Location: NE
ADA ID: 0F1ACA2A6E73	Ramp Type: PerpDiag	Initial Pass/Fail: Pass	Overall Compliance: No
Severity Score: 0.25			
Codes/Mitigation Info/Possible Solution		Field Measurements/Component Compliance

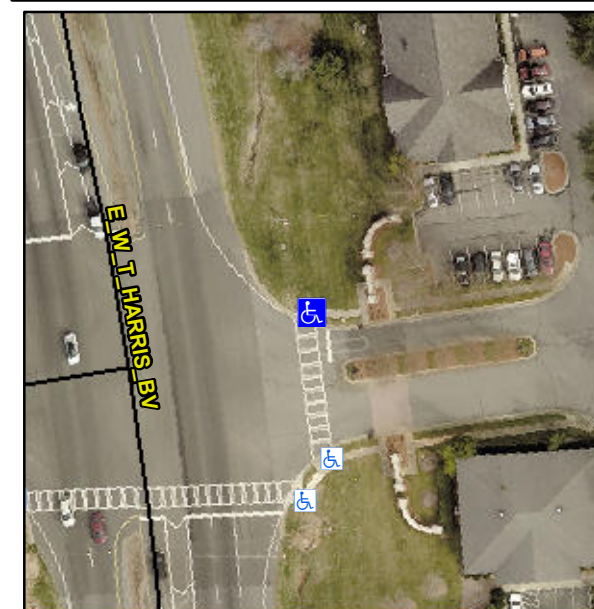
**Not Found, R304.5.3, R304.2.1**

Compliance	Description	Data	Compliance	Description	Data
N/A	Ramp Length (in)	49.0	Yes	Ramp Slope (%)	7.3
Yes	Ramp Width (in)	48.0	No	Ramp XSlope (%)	4.8
N/A	Flare Type LT	Sloped	N/A	Flare Type RT	N/A
N/A	Flare Slope LT (%)	6.8	N/A	Flare Slope RT (%)	8.7
N/A	Flare Traversable LT?	No	N/A	Flare Traversable RT?	No
No	Landing Length (in)	47.0	Yes	DWS Provided?	Yes
Yes	Landing Width (in)	48.0	Yes	DWS Contrast?	Yes
Yes	Landing Slope (%)	0.3	Yes	DWS Length (in)	24.0
No	Landing X Slope (%)	3.6	Yes	DWS Full Width?	Yes
N/A	Landing Curb? (Y/N)	No	Yes	DWS Offset (in)	2.0
N/A	Shared Landing?	No			
Yes	Gutter Ponding?	No	Yes	Gutter Slope (%)	4.6
Yes	Gutter Lip Ht (in)	0.0	Yes	Gutter X Slope (%)	2.6
N/A	Painted X Walk1?	No	N/A	Painted X Walk2?	Yes
	X Walk 1 Direction	To W		X Walk 2 Direction	To S
N/A	X Walk 1 Width (in)	N/A	N/A	X Walk 2 Width (in)	112.0
	X Walk 1 Slope (%)	3.1		X Walk 2 Slope (%)	3.1
	X Walk 1 X Slope (%)	1.7		X Walk 2 X Slope (%)	2.0

N/A	Ramp inside XWalk1?	N/A	Yes	Ramp inside XWalk2?	Yes
	Road Slope (%)	3.3	N/A	Clear Space?	Yes
	Road X Slope (%)	2.7	N/A	Clear Space to XWalk (in)	N/A
Yes	Any Obstructions?	No	Yes	Storm Grate/Utility Hazard?	No
	Obstruction Type			Storm Grate/Utility Type	
		N/A			N/A
			Yes	Surface Condition? (G/P)	Good

**Remove & Replace Curb Ramp With Two New Directional Ramps or Equivalent.**
