Access Compliance Report

Public Rights-of-Way

(Curb Ramps)

Intersection ID: 10014252	Main Street: PARKWOOD_AV	Cross Street: E_17TH_ST	Location: E
ADA ID: 0F1CF8B14882	Ramp Type: PerpDiag	Initial Pass/Fail: Fail	Overall Compliance: No
		Severity Score: 12.5

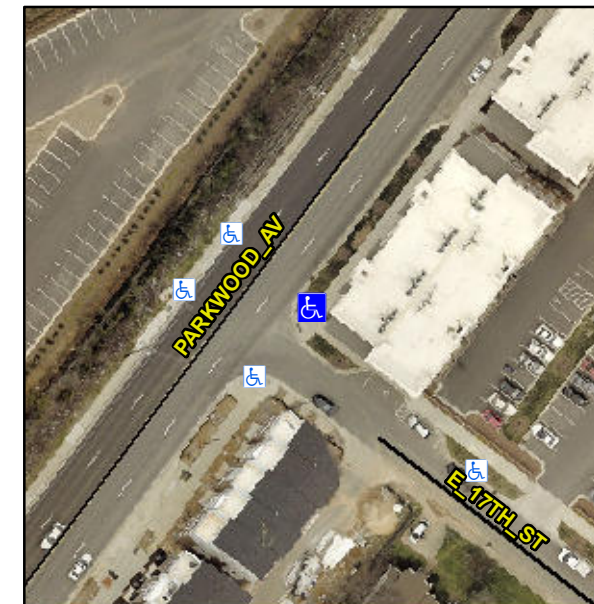
Compliance	Description	Data	Compliance	Description	Data
N/A	Ramp Length (in)	97.0	No	Ramp Slope (%)	9.7
Yes	Ramp Width (in)	60.0	Yes	Ramp XSlope (%)	0.9
N/A	Flare Type LT	N/A	N/A	Flare Type RT	N/A
N/A	Flare Slope LT (%)	N/A	N/A	Flare Slope RT (%)	N/A
N/A	Flare Traversable LT?	N/A	N/A	Flare Traversable RT?	N/A
N/A	Landing Length (in)	N/A	N/A	DWS Provided?	N/A
N/A	Landing Width (in)	N/A	N/A	DWS Contrast?	N/A
N/A	Landing Slope (%)	N/A	N/A	DWS Length (in)	N/A
N/A	Landing X Slope (%)	N/A	N/A	DWS Full Width?	N/A
N/A	Landing Curb? (Y/N)	N/A	N/A	DWS Offset (in)	N/A
N/A	Shared Landing?	N/A			
N/A	Gutter Ponding?	N/A	N/A	Gutter Slope (%)	N/A
N/A	Gutter Lip Ht (in)	N/A	N/A	Gutter X Slope (%)	N/A
N/A	Painted X Walk1?	No	N/A	Painted X Walk2?	No
	X Walk 1 Direction	To NW		X Walk 2 Direction	To SW
N/A	X Walk 1 Width (in)	N/A	N/A	X Walk 2 Width (in)	N/A
	X Walk 1 Slope (%)	1.6		X Walk 2 Slope (%)	1.5
	X Walk 1 X Slope (%)	1.3		X Walk 2 X Slope (%)	0.8

N/A	Ramp inside XWalk1?	N/A	N/A	Ramp inside XWalk2?	N/A
	Road Slope (%)	0.2	N/A	Clear Space?	N/A
	Road X Slope (%)	0.7	N/A	Clear Space to XWalk (in)	N/A
N/A	Any Obstructions?	N/A	N/A	Storm Grate/Utility Hazard?	N/A
	Obstruction Type			Storm Grate/Utility Type	
		N/A			N/A
		Yes		Surface Condition? (G/P)	Good

Remove & Replace Curb Ramp With Two New Directional Ramps or Equivalent.

R304.2.2
