# Access Compliance Report

## Public Rights-of-Way

### (Curb Ramps)

| Intersection ID: 25147 | Main Street: CARMEL_ESTATES_RD | Cross Street: REA_RD | Location: NE |

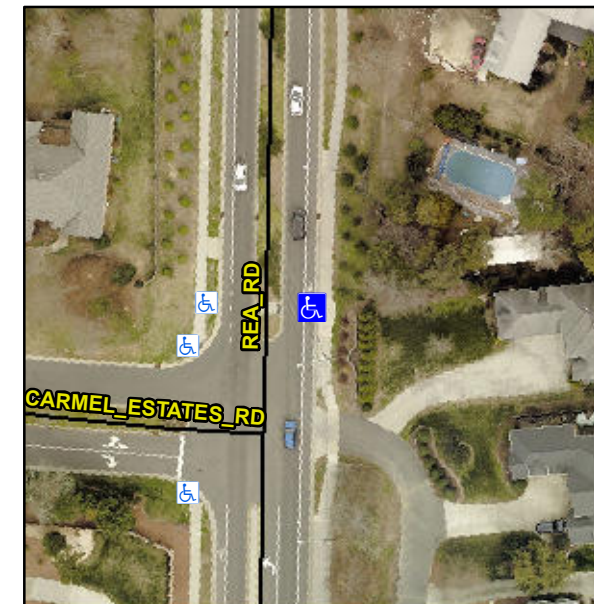
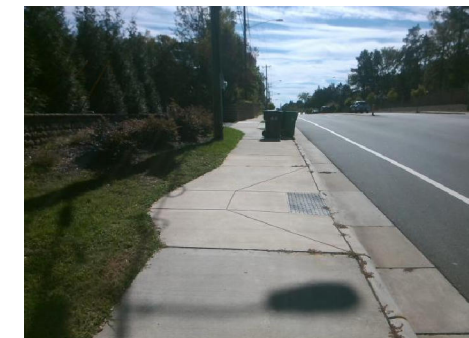
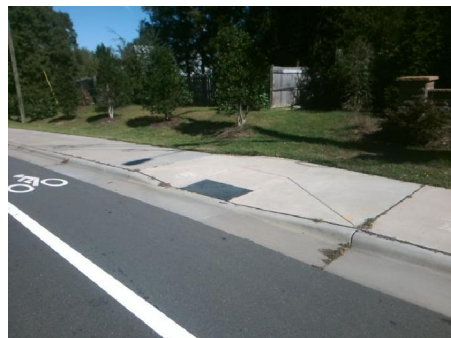
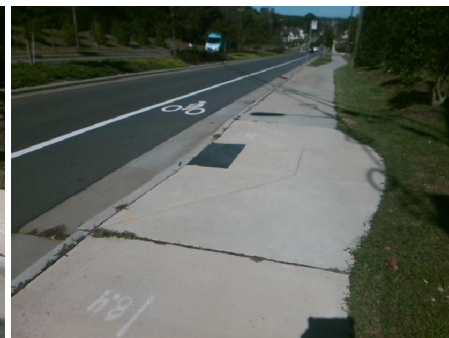
**Not Found, R304.2.1, R304.2.3,  
R304.5.3**

| Compliance | Description | Data | Compliance | Description | Data |
|---|---|---|---|---|---|
| N/A | Flare Slope LT (%) | 6.3 | No | Flare Slope RT (%) | 10.9 |
| No | Landing Length (in) | 47.0 | Yes | DWS Provided? | Yes |
| Yes | Gutter Lip Ht (in) | 0.0 | No | Gutter X Slope (%) | 5.6 |

**Remove & Replace Entire Ramp.  
Remove & Replace Gutter.**
