Access Compliance Report Public Rights-of-Way (Curb Ramps)

Intersection ID: 5781 Main Street: NEAL_RD Cross Street: IBM_DR Location:

ADA ID: 0F1F4FEDF422 Ramp Type: PerpDiag Initial Pass/Fail: Fail Overall Compliance: No Severity Score: 26.25

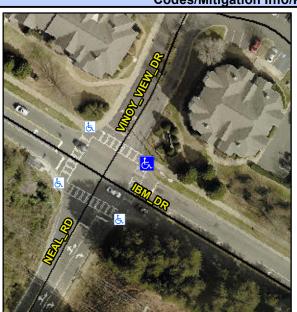
| Field Measurements/Component Compilance | | | | | |
|---|---|---|---|---|---|
| N/A | Ramp Length (in) | 204.0 | Yes | Ramp Slope (%) | 12.7 |
| Yes | Ramp Width (in) | 61.0 | Yes | Ramp XSlope (%) | 4.3 |
| N/A | Gutter Lip Ht (in) | 0.5 | N/A | Gutter X Slope (%) | N/A |

Remove & Replace Curb Ramp With
Two New Directional Ramps or
Equivalent.

Total Cost: \$ 3200.00
