# Access Compliance Report

## Public Rights-of-Way

### (Curb Ramps)

| Intersection ID: 14633 | Main Street: E_KINGSTON_AV | Cross Street: PARK_RD | Location: | W |

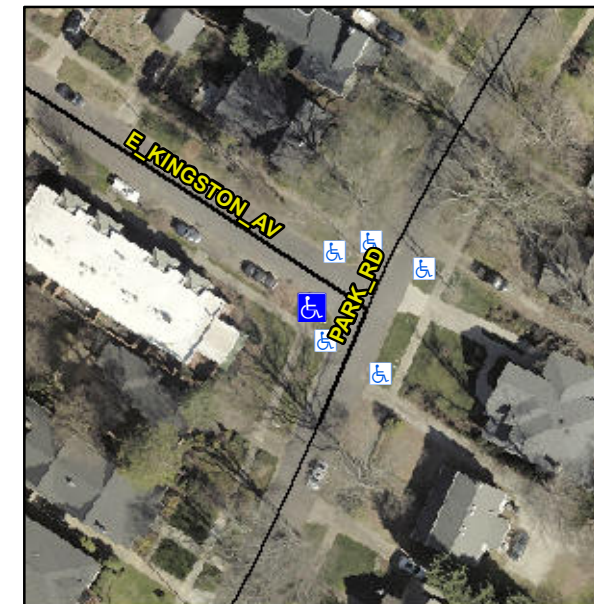
**Not Found, R304.2.2**

| Compliance | Description | Data | Compliance | Description | Data |
|---|---|---|---|---|---|
| N/A | Ramp Length (in) | 46.0 | No | Ramp Slope (%) | 15.9 |

**Remove & Replace Entire Ramp.**

Total Cost: \$ 1850.00
