# Access Compliance Report

## Public Rights-of-Way

| Intersection ID: 47576 | Main Street: BARRANDS_LN | Cross Street: SEDGEBURN_DR | Location: NW |
| ADA ID: 0F2503A3C75E | Ramp Type: PerpDiag | Initial Pass/Fail: Fail | Overall Compliance: No |

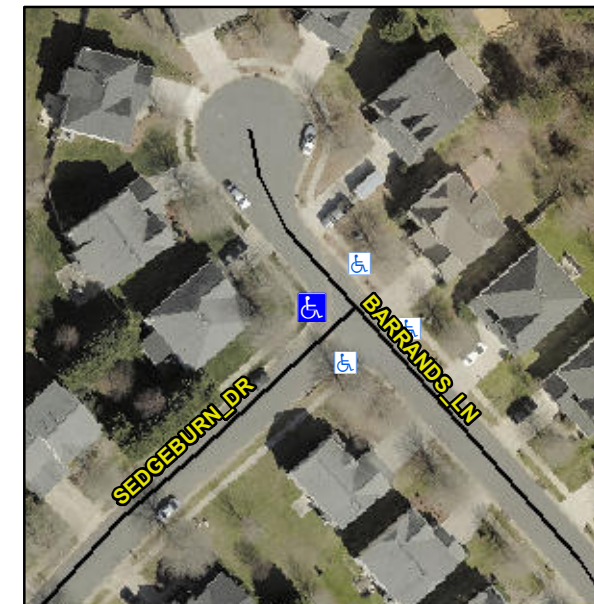
| Severity Score: 12.5 | | | |

| Compliance | Description | Data | Compliance | Description | Data |
|---|---|---|---|---|---|
| N/A | Ramp Length (in) | 48.0 | No | Ramp Slope (%) | 8.6 |

**Remove & Replace Curb Ramp With Two New Directional Ramps or Equivalent.**

**R304.2.2**

**\$ 3200.00**

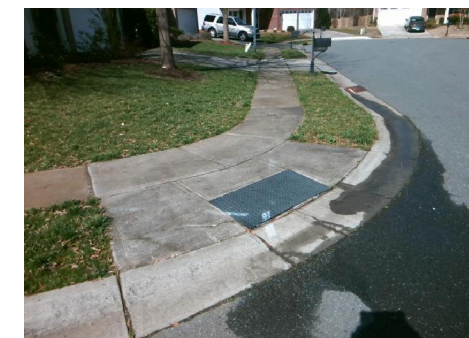
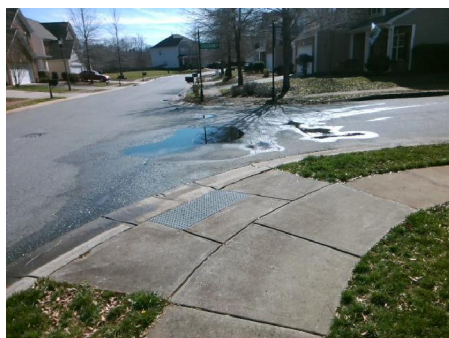
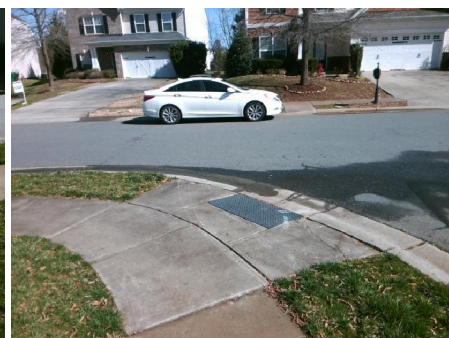
| Compliance | Description | Data | Compliance | Description | Data |
|---|---|---|---|---|---|
| | | Yes | | Surface Condition? (G/P) | Good |
