# Access Compliance Report

## Public Rights-of-Way

### (Curb Ramps)

| Intersection ID: 16139 | Main Street: BILTMORE_DR | Cross Street: CHEROKEE_RD | Location: E |

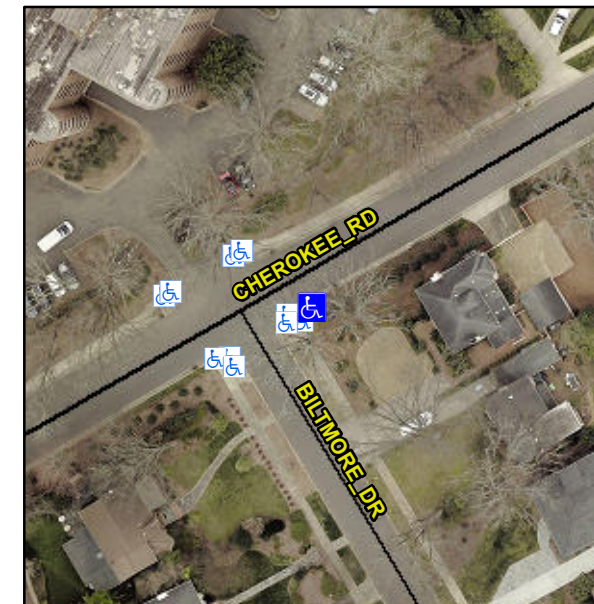
| ADA ID: 0F2E9AF5E8E6 | Ramp Type: BlendTrans1 | Initial Pass/Fail: Pass | Overall Compliance: No |
| Severity Score: 0.25 | | | |

**Not Found, R304.5.3**

| Compliance | Description | Data | Compliance | Description | Data |
|---|---|---|---|---|---|
| Yes | Ramp Width (in) | 58.0 | No | BlendTrans XSlope (%) | 2.5 |
| | | | No | Curb Slope (%) | 5.2 |

**Remove & Replace Curb Ramp With Two New Directional Ramps or Equivalent.**

Total Cost: \$ 3200.00
