# Access Compliance Report

## Public Rights-of-Way

### (Curb Ramps)

Intersection ID: 13156	Main Street: S_TRYON_ST	Cross Street: W_CARSON_BV	Location: W
ADA ID: 0F35E46DE3DA	Ramp Type: Perp	Initial Pass/Fail: Fail	Overall Compliance: No
			Severity Score: 26.25

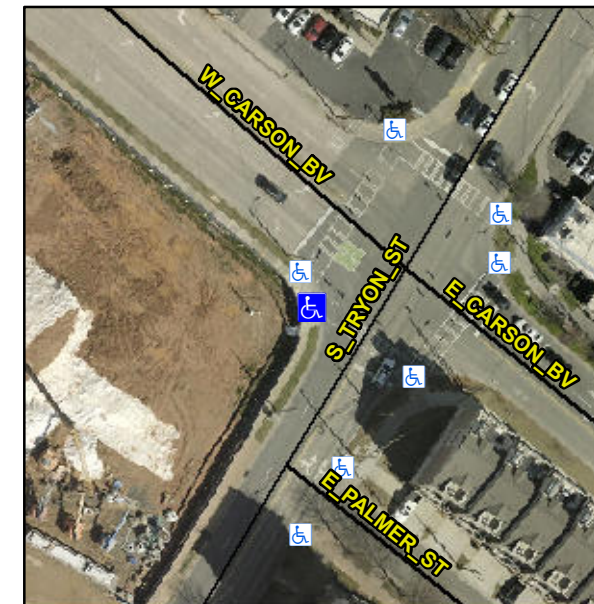
**R304.2.2**

Compliance	Description	Data	Compliance	Description	Data
N/A	Ramp Length (in)	62.5	No	Ramp Slope (%)	15.6
Yes	Ramp Width (in)	48.0	Yes	Ramp XSlope (%)	2.5
N/A	Flare Type LT	N/A	N/A	Flare Type RT	N/A
N/A	Flare Slope LT (%)	N/A	N/A	Flare Slope RT (%)	N/A
N/A	Flare Traversable LT?	N/A	N/A	Flare Traversable RT?	N/A
N/A	Landing Length (in)	N/A	N/A	DWS Provided?	N/A
N/A	Landing Width (in)	N/A	N/A	DWS Contrast?	N/A
N/A	Landing Slope (%)	N/A	N/A	DWS Length (in)	N/A
N/A	Landing X Slope (%)	N/A	N/A	DWS Full Width?	N/A
N/A	Landing Curb? (Y/N)	N/A	N/A	DWS Offset (in)	N/A
N/A	Shared Landing?	N/A			
N/A	Gutter Ponding?	N/A	N/A	Gutter Slope (%)	N/A
N/A	Gutter Lip Ht (in)	N/A	N/A	Gutter X Slope (%)	N/A
N/A	Painted X Walk1?	Yes	N/A	Painted X Walk2?	N/A
	X Walk 1 Direction	To SE		X Walk 2 Direction	N/A
N/A	X Walk 1 Width (in)	103.0	N/A	X Walk 2 Width (in)	N/A
	X Walk 1 Slope (%)	1.6		X Walk 2 Slope (%)	N/A
	X Walk 1 X Slope (%)	2.6		X Walk 2 X Slope (%)	N/A

**Remove & Replace Entire Ramp.**
