Access Compliance Report

Public Rights-of-Way

(Curb Ramps)

Intersection ID: 17085	Main Street: CROYDON_RD	Cross Street: SELWYN_AV	Location: NE
ADA ID: 0F3833A4F7B6	Ramp Type: PerpDiag	Initial Pass/Fail: Fail	Overall Compliance: No
Severity Score: 13.75			
Codes/Mitigation Info/Possible Solution		Field Measurements/Component Compliance

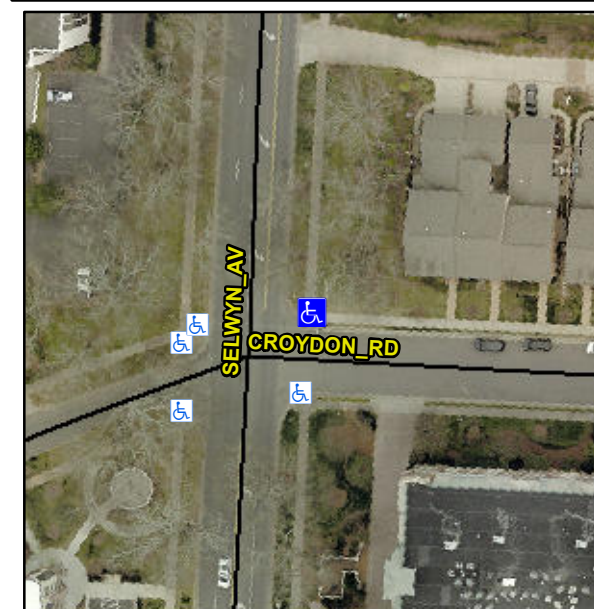
Not Found, R304.2.2, R304.5.3

Compliance	Description	Data	Compliance	Description	Data
N/A	Ramp Length (in)	45.0	No	Ramp Slope (%)	11.7
Yes	Ramp Width (in)	49.0	No	Ramp XSlope (%)	2.7
N/A	Flare Type LT	N/A	N/A	Flare Type RT	N/A
N/A	Flare Slope LT (%)	N/A	N/A	Flare Slope RT (%)	N/A
N/A	Flare Traversable LT?	N/A	N/A	Flare Traversable RT?	N/A
N/A	Landing Length (in)	N/A	N/A	DWS Provided?	N/A
N/A	Landing Width (in)	N/A	N/A	DWS Contrast?	N/A
N/A	Landing Slope (%)	N/A	N/A	DWS Length (in)	N/A
N/A	Landing X Slope (%)	N/A	N/A	DWS Full Width?	N/A
N/A	Landing Curb? (Y/N)	N/A	N/A	DWS Offset (in)	N/A
N/A	Shared Landing?	N/A			
N/A	Gutter Ponding?	Yes	N/A	Gutter Slope (%)	N/A
N/A	Gutter Lip Ht (in)	N/A	N/A	Gutter X Slope (%)	N/A
N/A	Painted X Walk1?	No	N/A	Painted X Walk2?	No
	X Walk 1 Direction	To W		X Walk 2 Direction	To SW
N/A	X Walk 1 Width (in)	N/A	N/A	X Walk 2 Width (in)	N/A
	X Walk 1 Slope (%)	4.4		X Walk 2 Slope (%)	3.5
	X Walk 1 X Slope (%)	0.4		X Walk 2 X Slope (%)	1.6

N/A	Ramp inside XWalk1?	N/A	N/A	Ramp inside XWalk2?	N/A
	Road Slope (%)	1.6	N/A	Clear Space?	N/A
	Road X Slope (%)	1.7	N/A	Clear Space to XWalk (in)	N/A
N/A	Any Obstructions?	N/A	N/A	Storm Grate/Utility Hazard?	N/A
	Obstruction Type			Storm Grate/Utility Type	
		N/A			N/A
		Yes		Surface Condition? (G/P)	Good

Remove & Replace Curb Ramp With Two New Directional Ramps or Equivalent.
